IVEAGH MARKET,  
FRANCIS STREET, DUBLIN 8.

DILAPIDATION SURVEY & REPAIR RECOMMENDATIONS

FV  
January 2019

HOWLEY HAYES ARCHITECTS

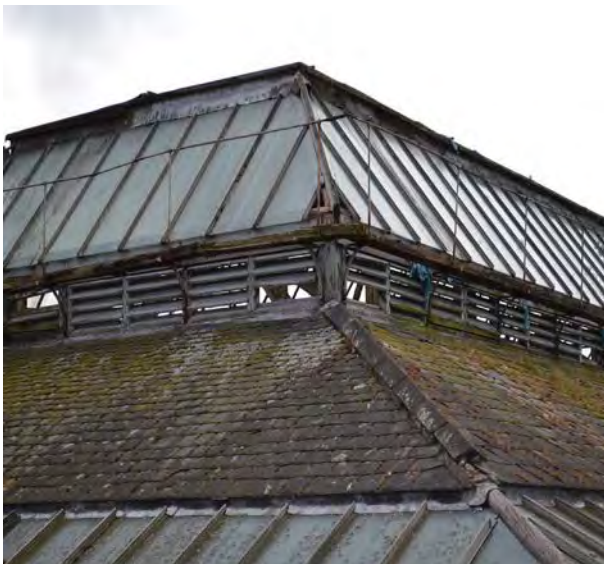
Fig. 23. Detail of damaged hip and lantern on roof of Dry Market.

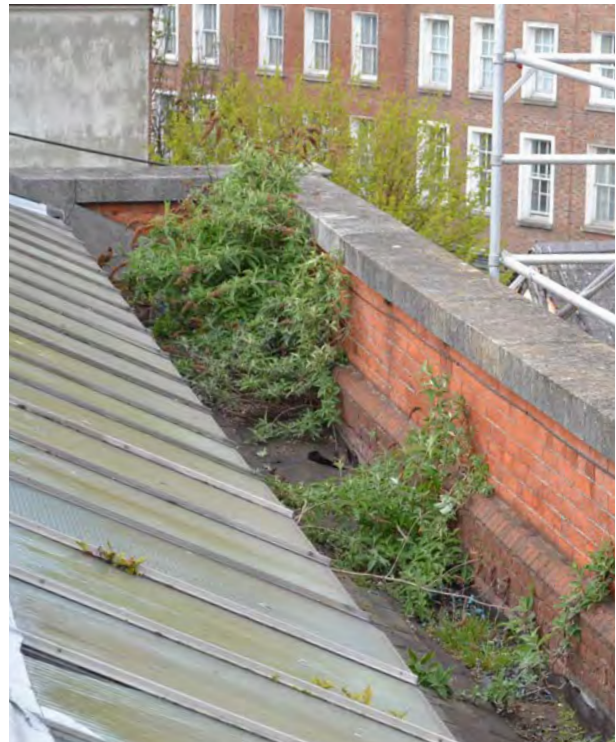
Fig.28. General view of a typical parapet valley.

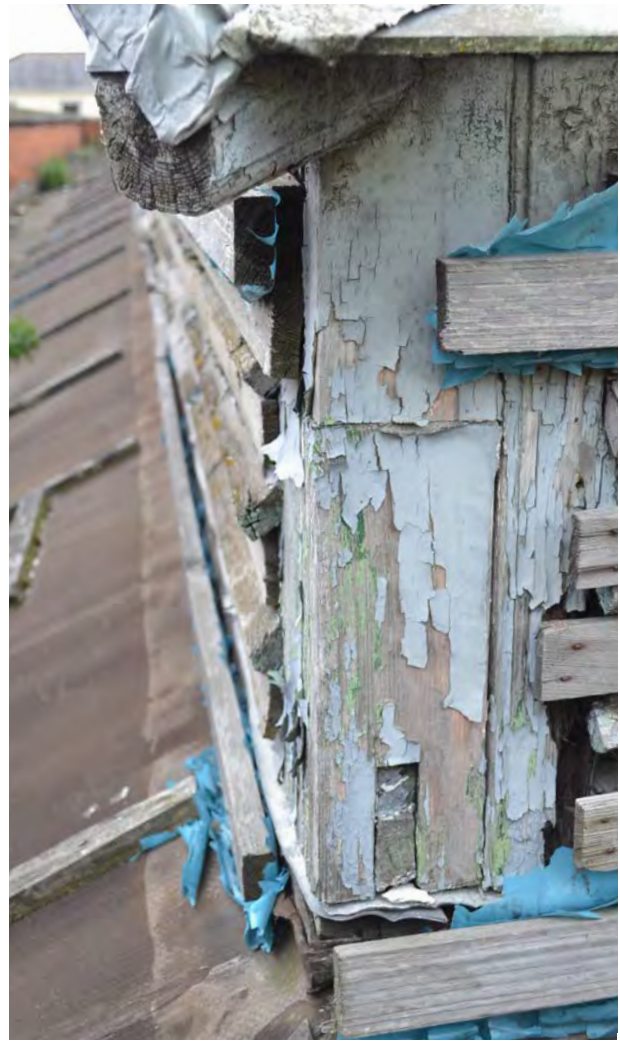
Fig.31. Damage to timber louvres at base of lantern.

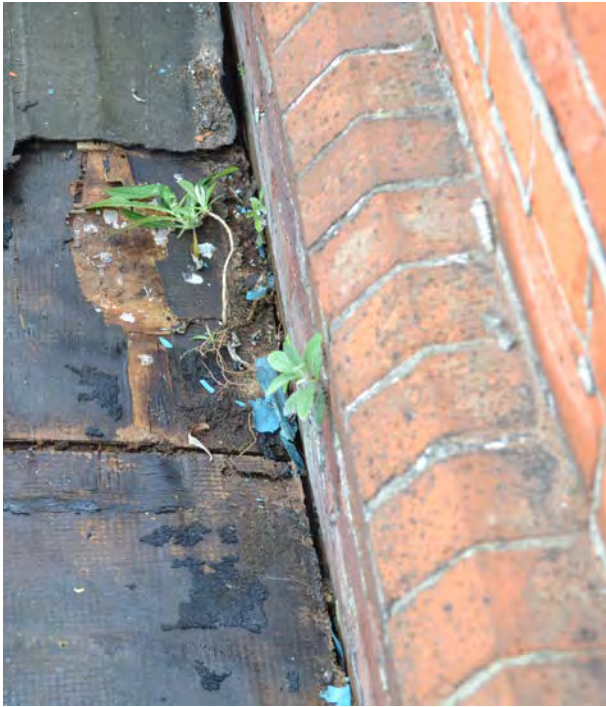
Fig.33.Linings of parapet valleys are missing in many places.

The third factor that has contributed to the serious water ingress and subsequent damage to the roofs is the almost total lack of flashings and counter flashings. It would appear that in many places these have been stolen and only in isolated areas has a poor-quality, torch-on felt been added to try to repair the damage caused. As a result, water is entering the building in a multitude of different places. Ridge and hip rolls are not weathered, valley linings not flashed into parapets and junctions between lanterns and slated roof slopes are currently exposed and vulnerable. These sources of water ingress, combined with broken or missing panes of glass and damaged slates, have caused untold damage to the underlying timbers to the point that the roof is now in a very dangerous and fragile state. It will be necessary to strip the entire roof of all slate and glazing to identify damage to the underlying timber members and metal structure. When these have been repaired or replaced the roof coverings can be re-fixed, incorporating any salvaged, sound slates, while the roof glazing will have to be renewed, together with all valley linings, hips and flashings.

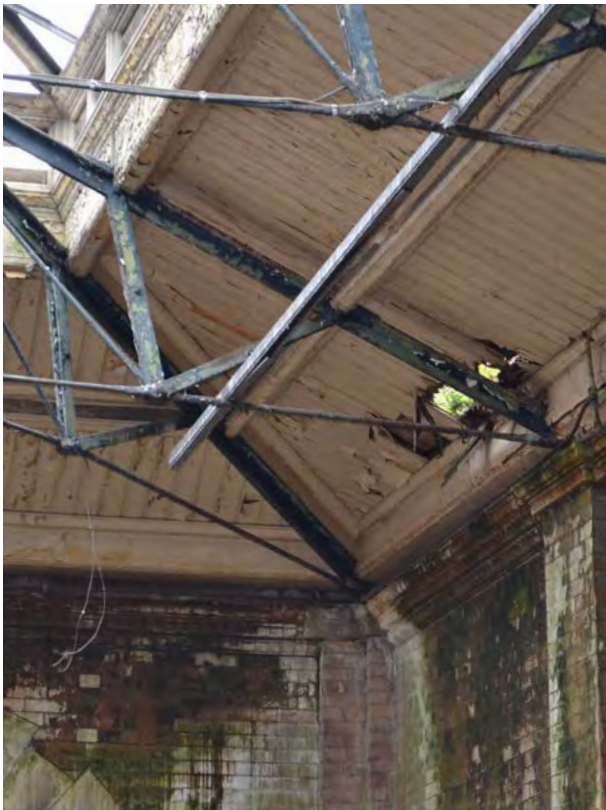
Fig.34. Detail of roof in the Wet Market showing unrepaired holes with water damage and algae growth on interior walls.

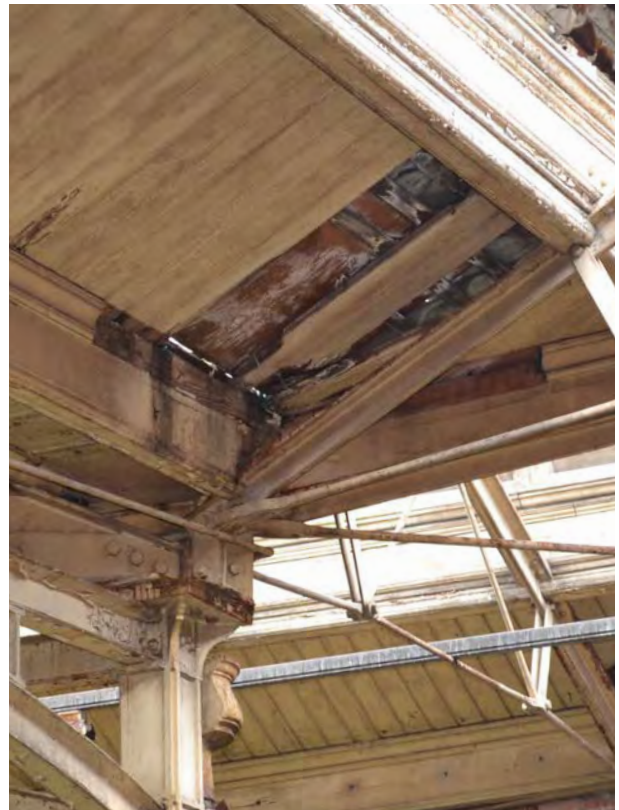
Fig.35. Damage to timber boarding of roof/ceiling.

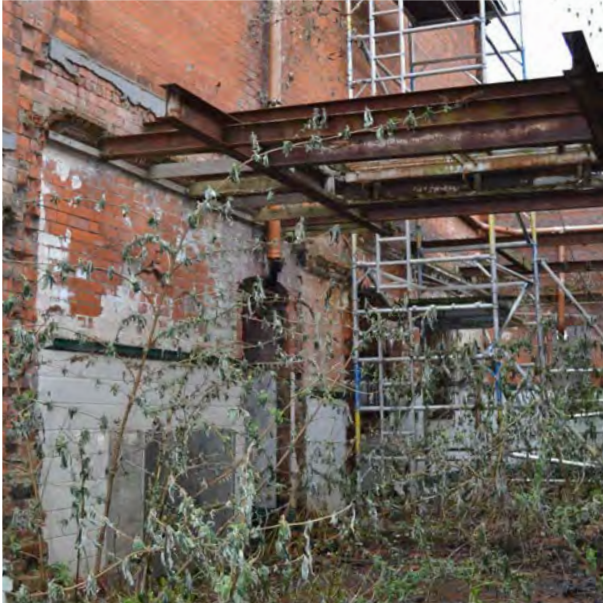
All that remains of the roof of the single storey block that runs between the two market halls is a series of rusted rolled steel joists, and a deep chase in the brickwork above. This would suggest a timber roof construction supported by the steels, with a sheet or poured membrane finish. Like the main roofs the link roof will require major work to rebuild and re-weather.

Fig.36. Now roofless single storey link between Wet and Dry Market.

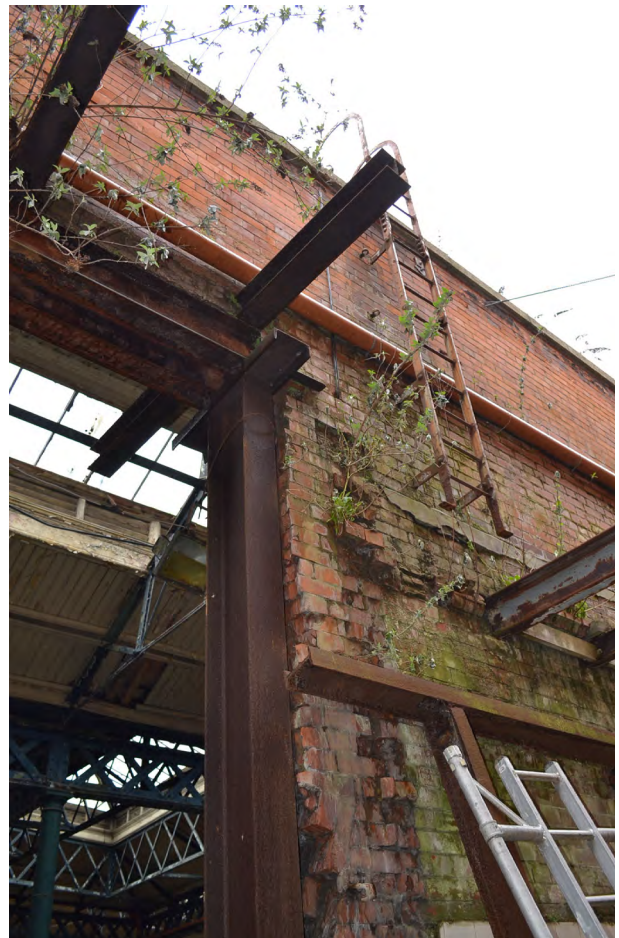
Fig.37. Damage to single story link.

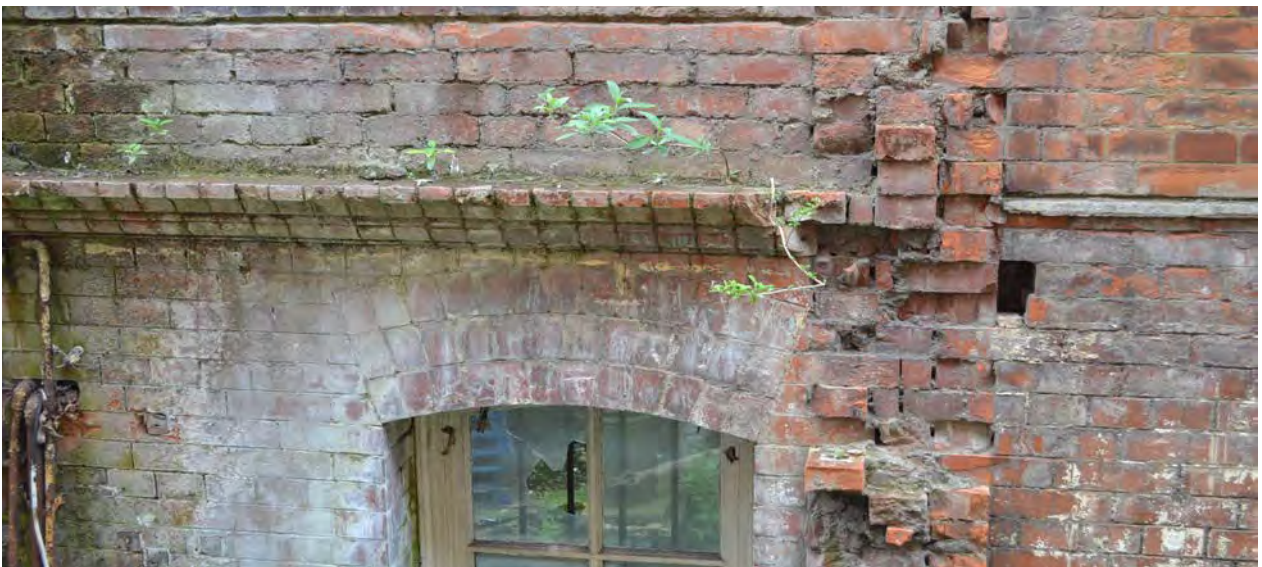
Fig.38. Original brick walls demolished in linking range.

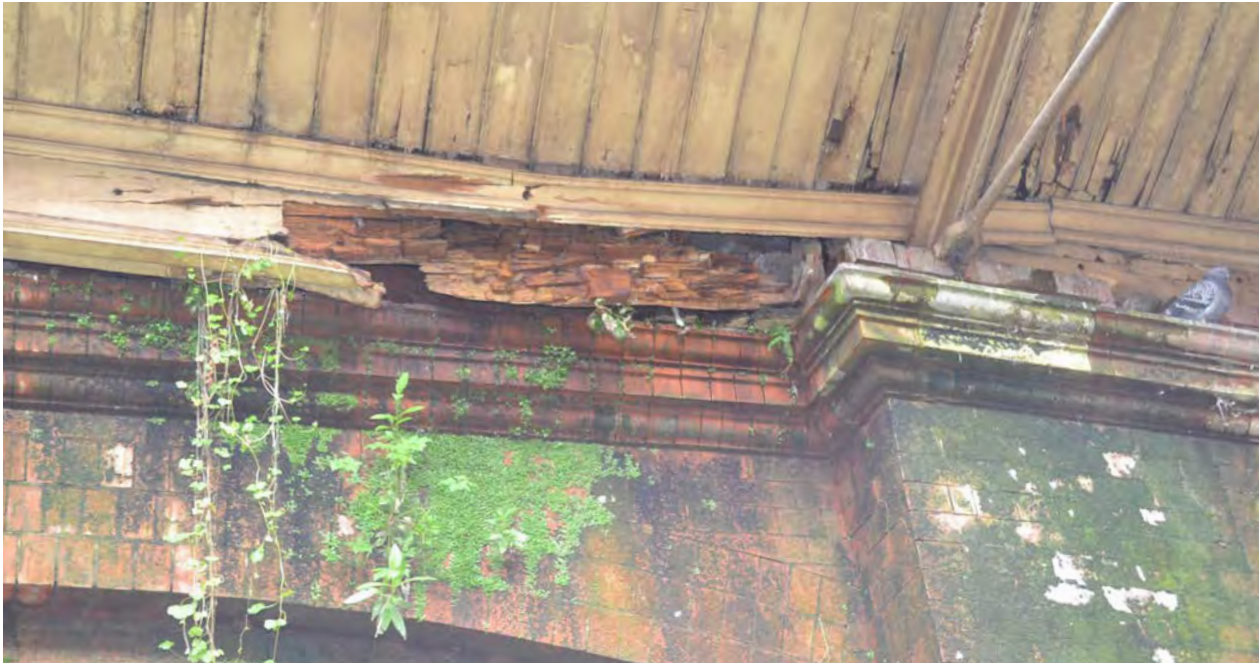
Fig.42. Severe wet rot in valley boards of Dry Market roof.

The entire roof and rainwater disposal system will have to be stripped back to sound material. As the main roof structure is constructed of metal, it is hopeful that this will survive in a reasonable state and will require only localised repair and repainting. All of the beautiful Westmorland slate will have to be stripped, and it is possible that up to 30% might be salvaged for reuse. All battens, boarding and parapet valley linings will have to be stripped and a very large proportion of these will most likely have to be replaced. While the aluminium patent glazing survives in a fair to poor condition, it would be a false economy to try to salvage and reuse these and the glass is similarly of mediocre quality. It may be possible to salvage the cast iron, inner valleys but this will only be known when the roof is stripped. The extent of timber decay in the purlins and the timber framing and louvres of the lantern plinths is likely to be significant and a high proportion of replacement will be necessary in this area as will the other decorative timber trims and cover pieces seen from inside. Repairs will also be necessary to the access ladders and gantries and when repaired these will play an important part in providing safe access for regular, on-going maintenance to the repaired roof.

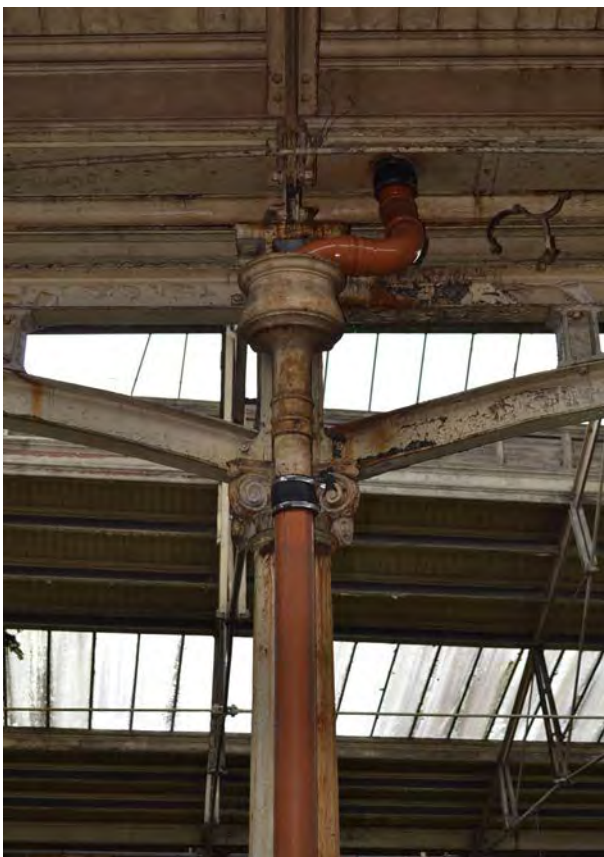
Fig.43. Detail of original cast iron hopper with replacement uPVC

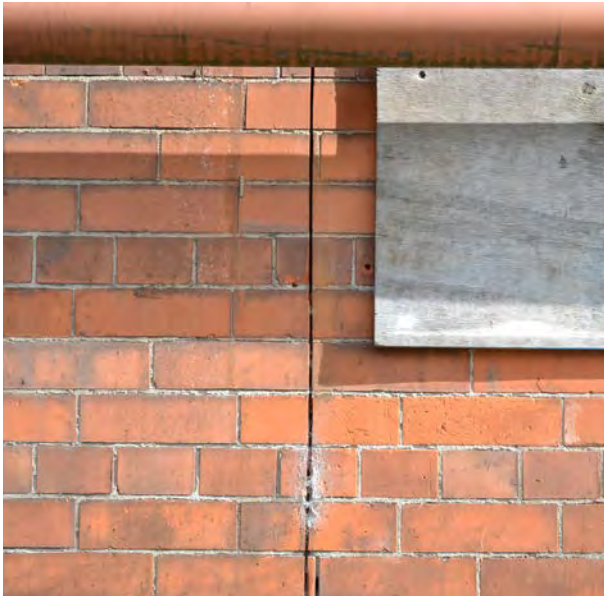
Fig. 65. Saw cut brickwork to one panel where brickwork only partially removed in dry market.

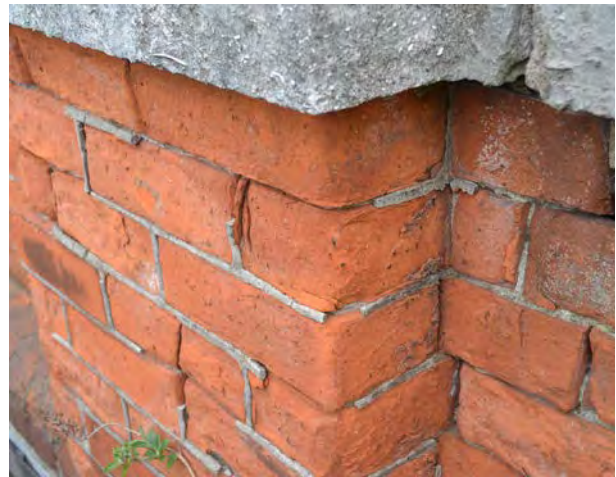
The most serious damage to the brickwork occurs in many areas both on the external facades and to the internal faces, at and below the parapets. This damage has been caused by a combination of saturation due to failing rainwater disposal, followed by frost action, causing a deterioration of the brick facings in places. In many areas there are thick coverings of algae where persistent leaking has occurred from failing gutters and in these areas the bed joints will be badly damaged. It is likely that due to the saturation and soiling that the brick work will have to be entirely repointed, following a thorough cleaning and during this process the replacement of a significant number of damaged bricks should be anticipated.

Fig.64. Damage to faces of brickwork to inner faces of parapet walls.

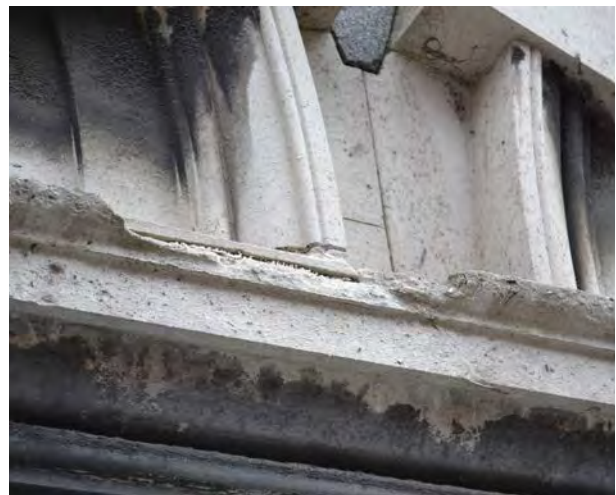
Fig.66. Damage to Portland stone cornice.

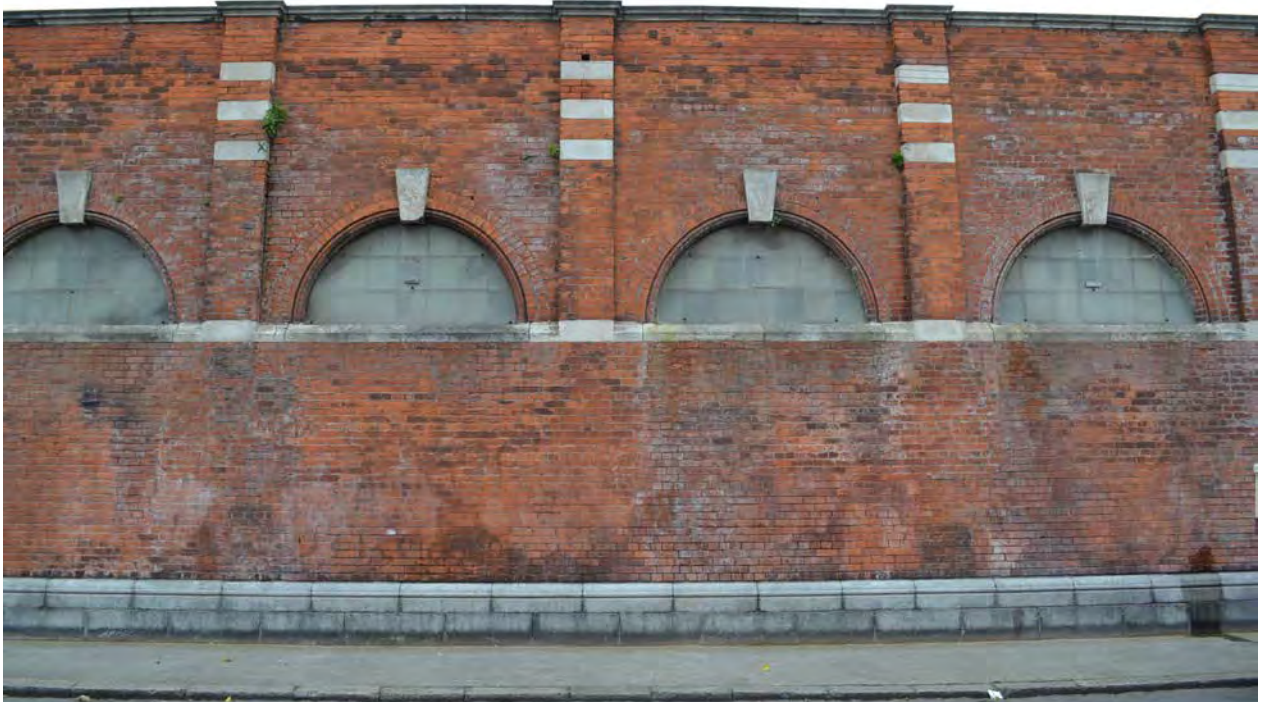
Fig.67. Detail of damaged brickwork to south façade on Dean Swift Square.

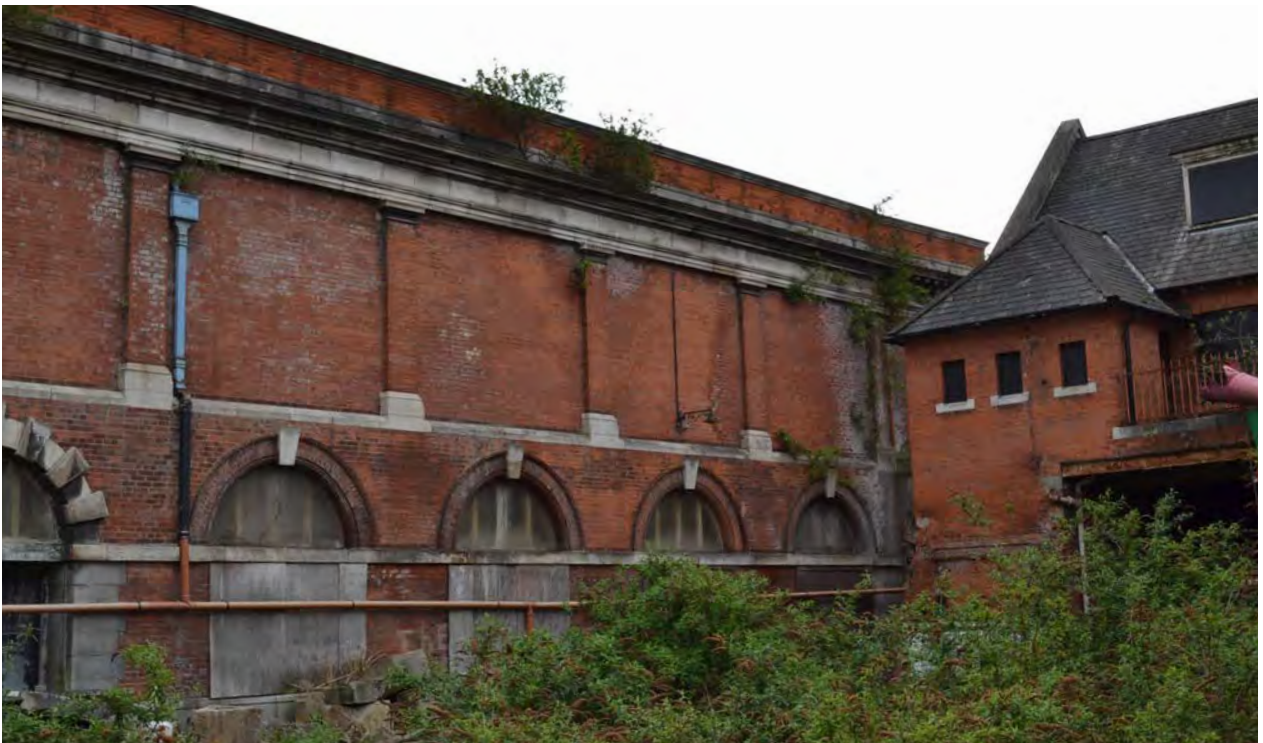
Fig. 68. Serious staining and plant growth to brickwork of north façade.

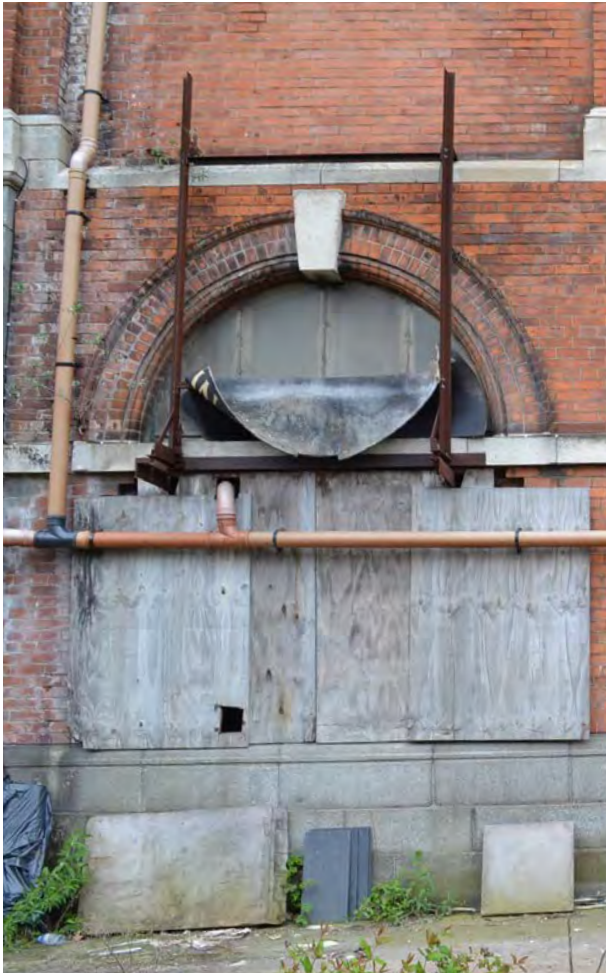
removal of the brick panels under the Diocletian style windows beneath the north gallery of the Dry Market. Currently the arched windows plus two courses of brickwork directly underneath their cills are supported precariously on timber props or by hanging metal frames, and these require urgent attention to avoid further damage. Brickwork has also been removed from the inner wall faces underneath some of the east facing windows in the former Wet Market, while brick partitions have been removed from the central, single-storey range between the two market halls and around the two staircases in the Dry Market. In the wet market only the inner portion of the wall thickness has been removed so the windows above them retain some measure of support. However, this damage should also be repaired as a matter of urgency.

Fig. 69. Temporary boarding where brick panels have been removed under windows.

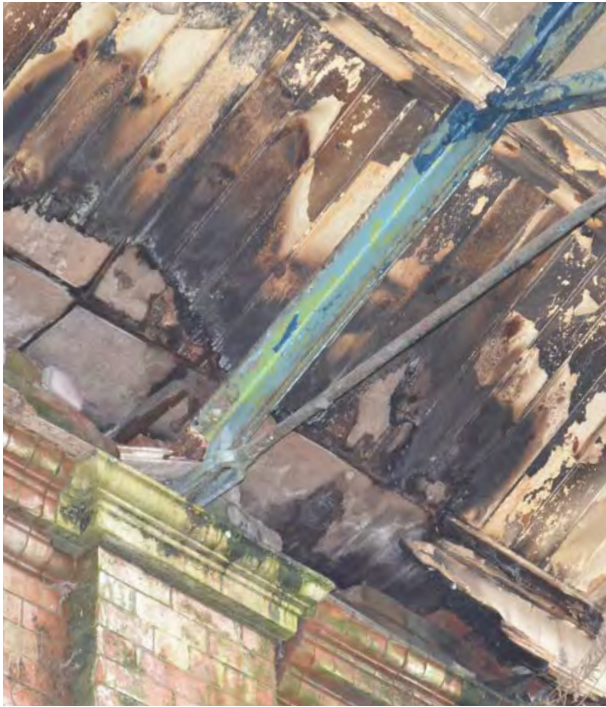
and purlins. Large areas of these timber linings have now deteriorated due to the widespread outbreaks of wet rot that have resulted from failing roofs and valley gutters. As the timber is of typically high quality there is a possibility that some might be salvaged and reused, however, it is highly likely that most will have to be replaced to matching details.

Fig.88. Severe rot infestation to underside of roof boarding.

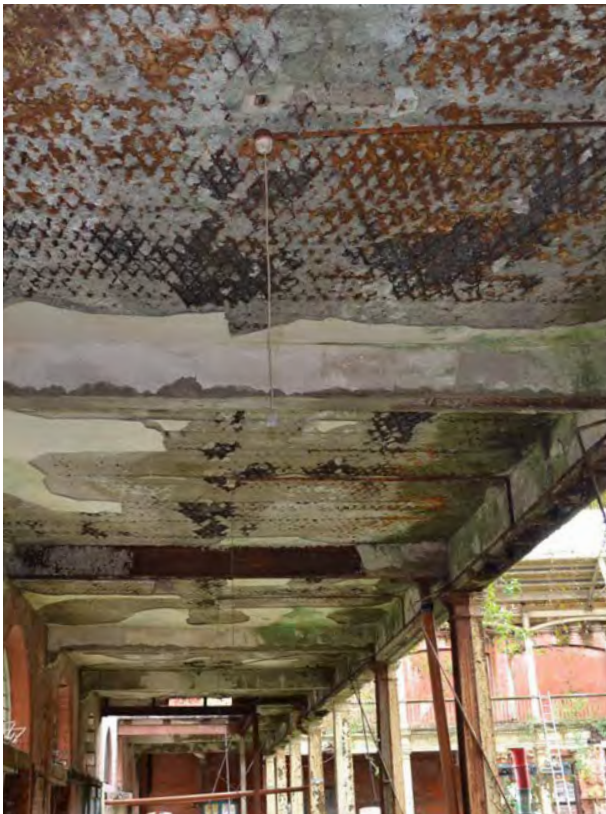
Fig.90. Damage to underside of north gallery.

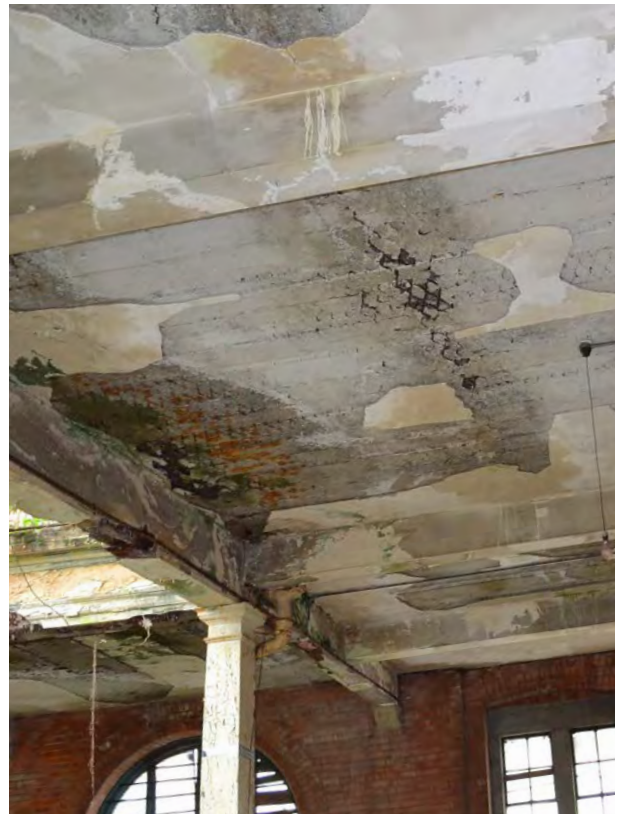
Fig.91. Damage to soffit of concrete gallery in the Dry Market.

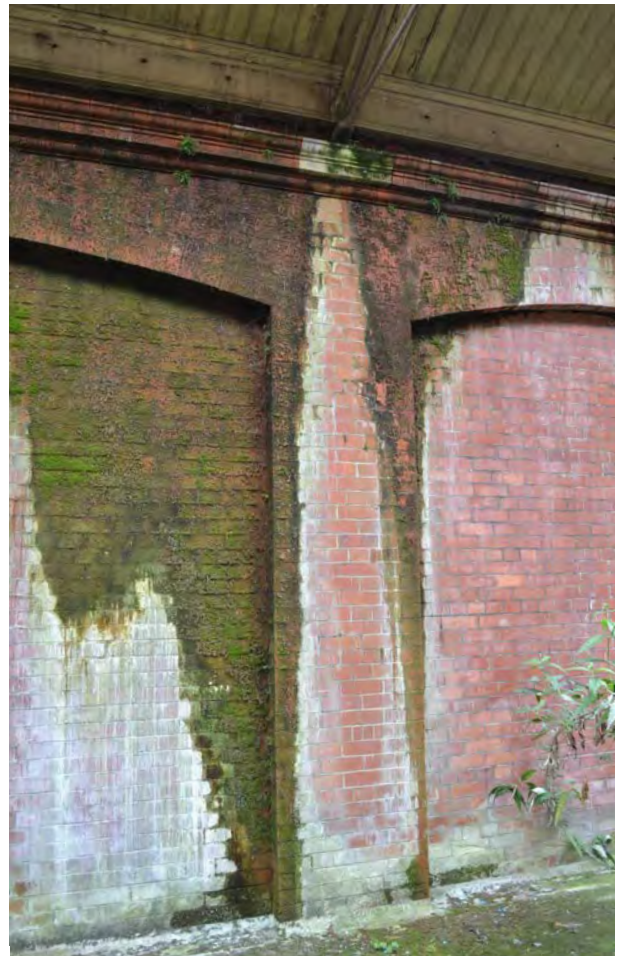
While the internal brickwork has suffered from less frost damage than the exterior faces, it has nonetheless suffered much damage and staining from leaking valley gutters. Throughout much of the building a thick green coating of saturated alga exists, which is not only staining the faces of the brickwork, but also eating away at the lime bed joints. It is likely that the entire internal face of the brick work will require cleaning and repointing after it has had time to dry out. As noted previously demolished sections of the north or east façade, together with the range of single-storey connecting rooms should be rebuilt.

Fig.96. Heavy staining to internal brickwork due to water ingress.

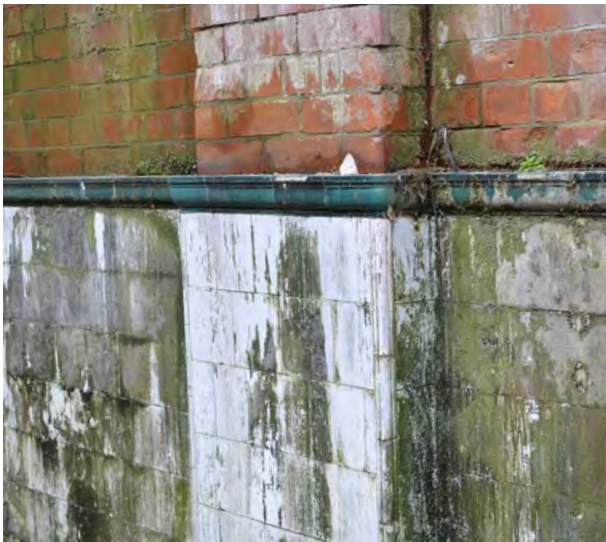
Fig. 97. Severe water staining and algae in wet market.

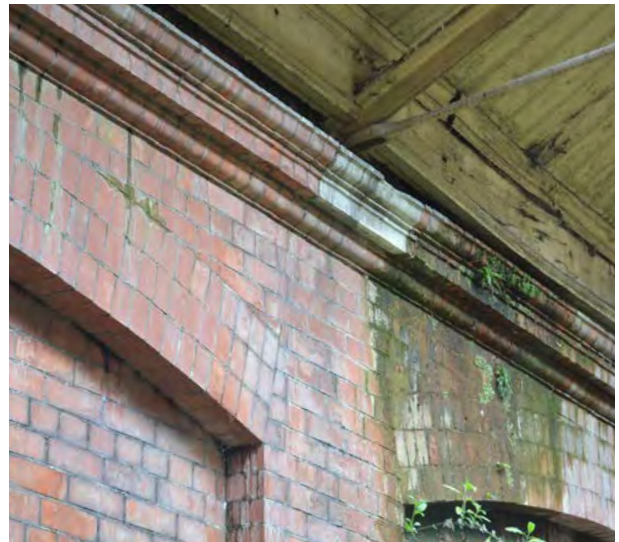
Fig.98. Damaged timber roof boarding and heavy staining to internal brickwork due to water ingress.

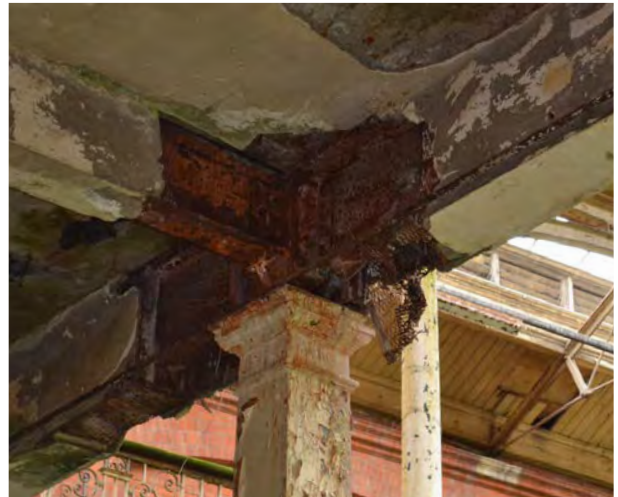
Fig. 99. Rust damage to column and beam supports of gallery in Dry Market.

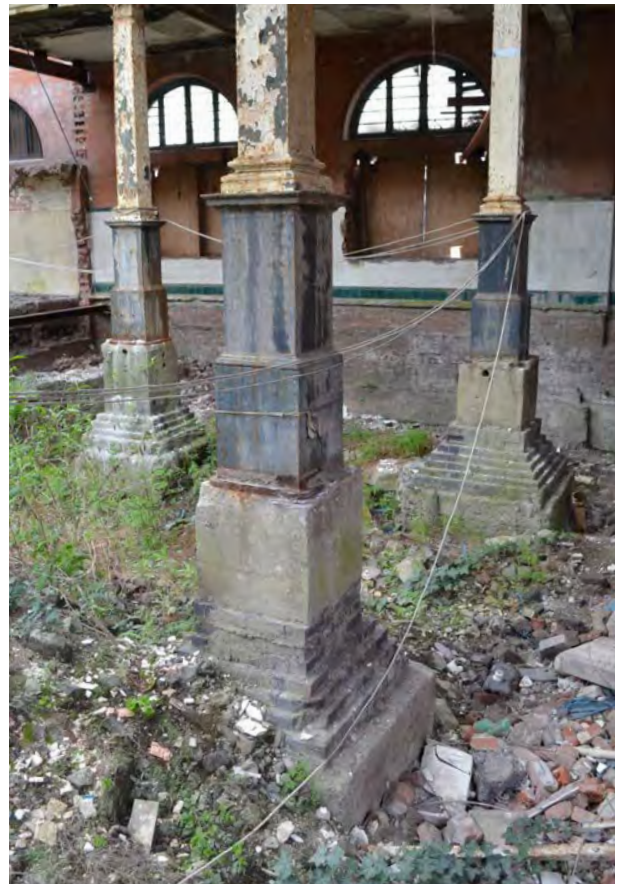
Fig. I02. Excavated column foundations in Dry Market.

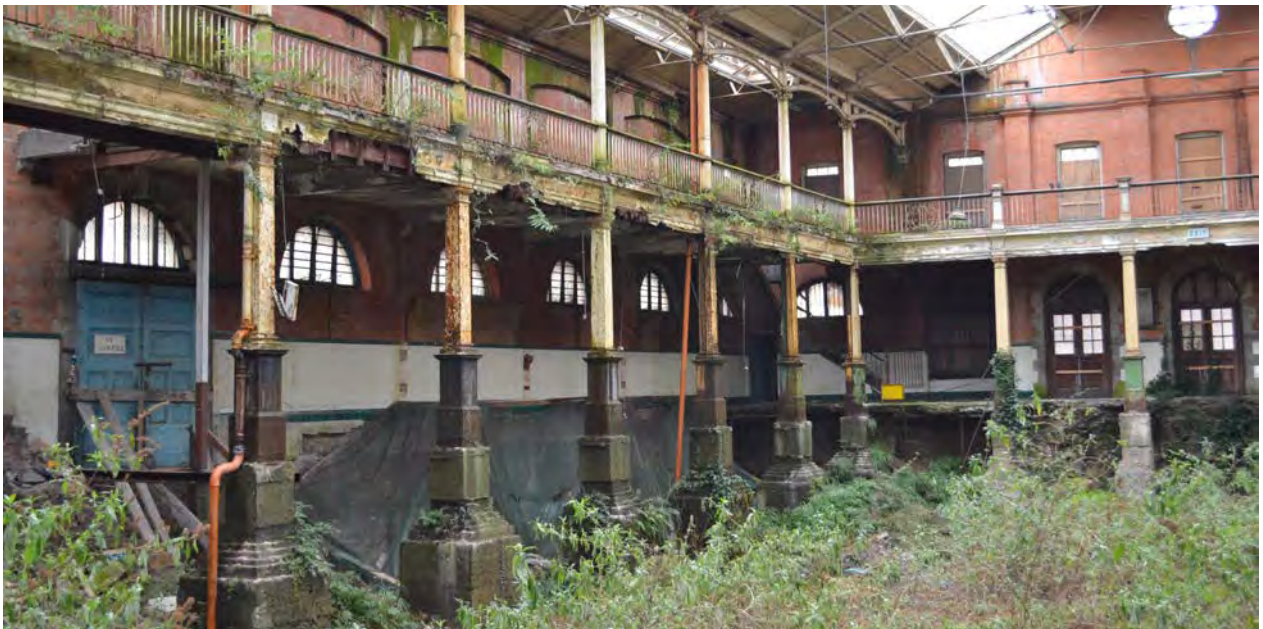
The ground floor was constructed as a load bearing slab, however, most of this has been removed in the Dry Market and in significant parts of the Wet Market, where the ground has also been lowered to a depth of between two and three meters. We are informed that this work was apparently carried out as an archaeological dig to determine whether or not it would be viable to construct a basement under the building. During this work remains of a number of historic structures were uncovered, some dating back to the seventeenth century. These ruins remain in view, as the excavations were never back filled. Now colonised by significant plant grown, this deep excavation is now dangerous, unstable and makes repair work to the roof and walls all the more challenging. Such is the depth of excavation that the pad foundations supporting the columns have been fully exposed and their bearing capacity reduced due to the lack of lateral restraint provided by the compacted fill that has been removed. In some locations there are large areas of standing water, suggesting that the excavations have extended down to below the water table. A major programme of back filling and consolidation will be necessary before any significant works can be carried out on the repair of this building.

Fig. I03. General interior view of Dry Market showing excavated floor, exposed column foundations and subsequent plant growth.

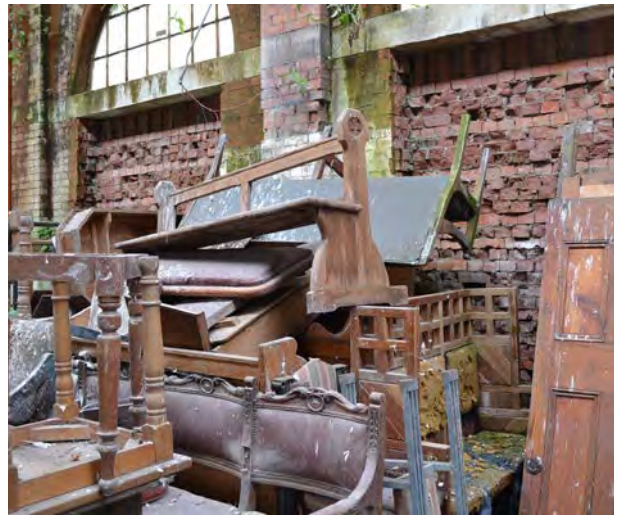
Fig.104. General rubbish and debris in the Wet Market.

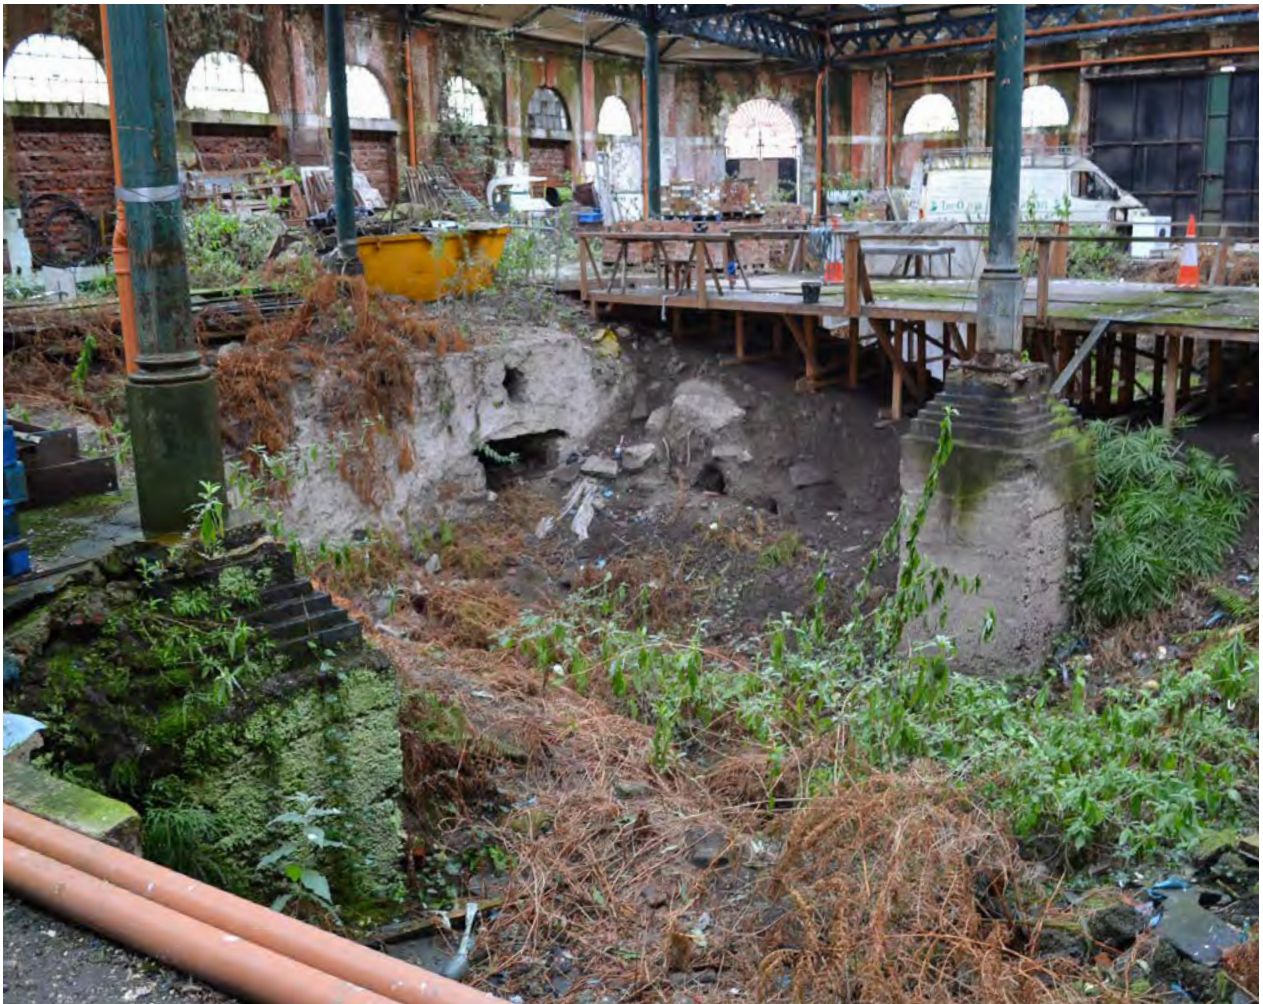
Fig.105. Excavated floor of the Wet Market.

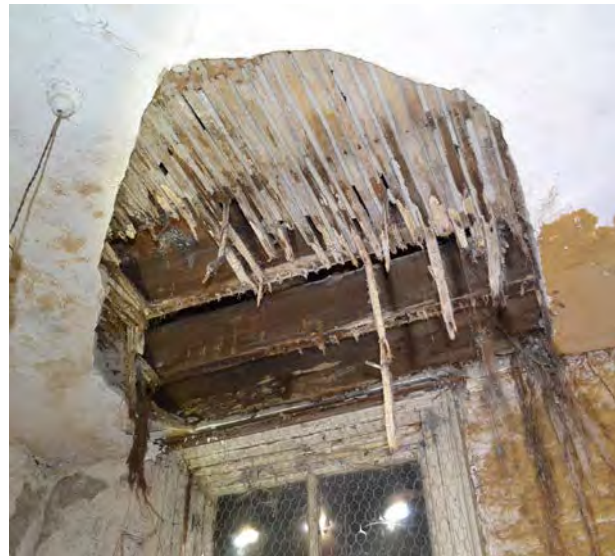
Fig. I 12. Signs of significant water ingress and ceiling damage in south east corner of market superintendent's house.

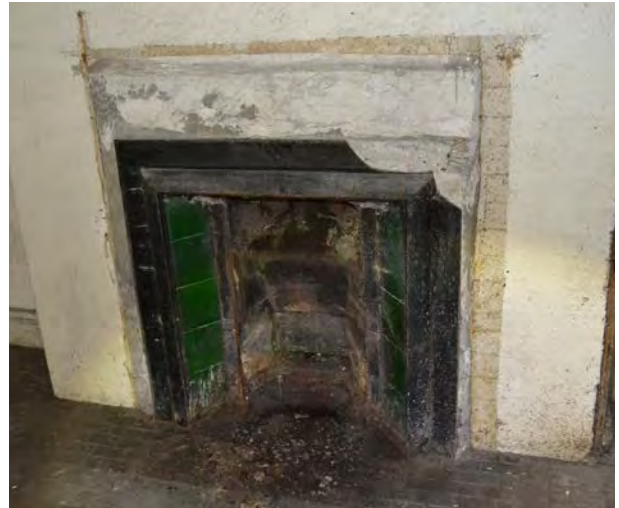
Fig. I 17. Damaged, original fireplace in the market superintendent's house.

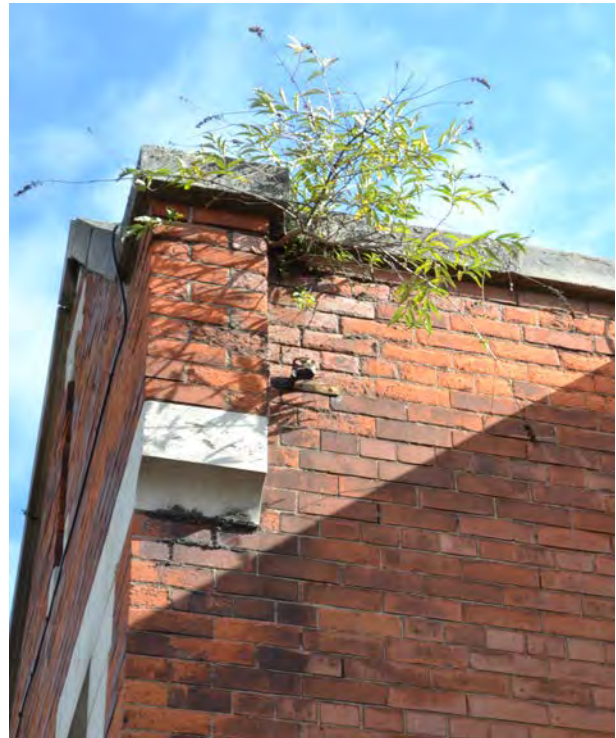
Fig.203. Damaged brickwork and plant growth in laundry superintendent's house.

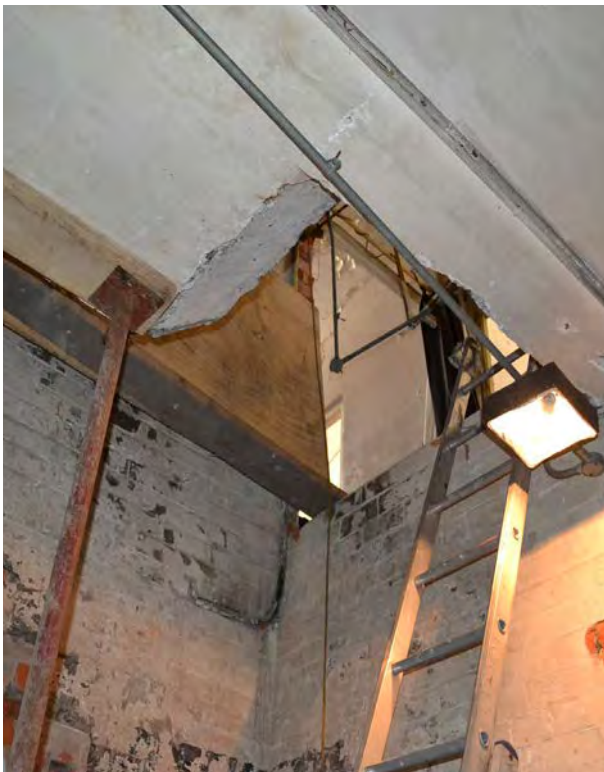
Fig.208. Open well in concrete ground floor where basement staircase removed in laundry superintendent's house.

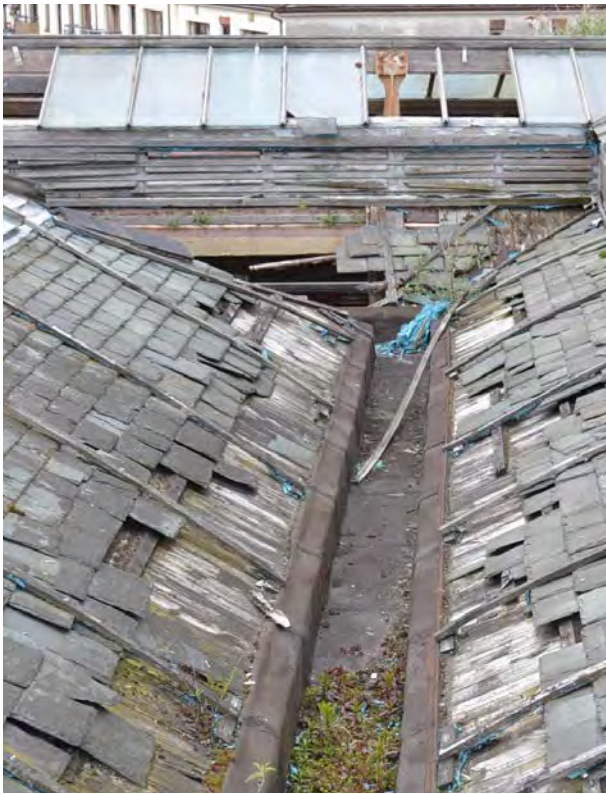
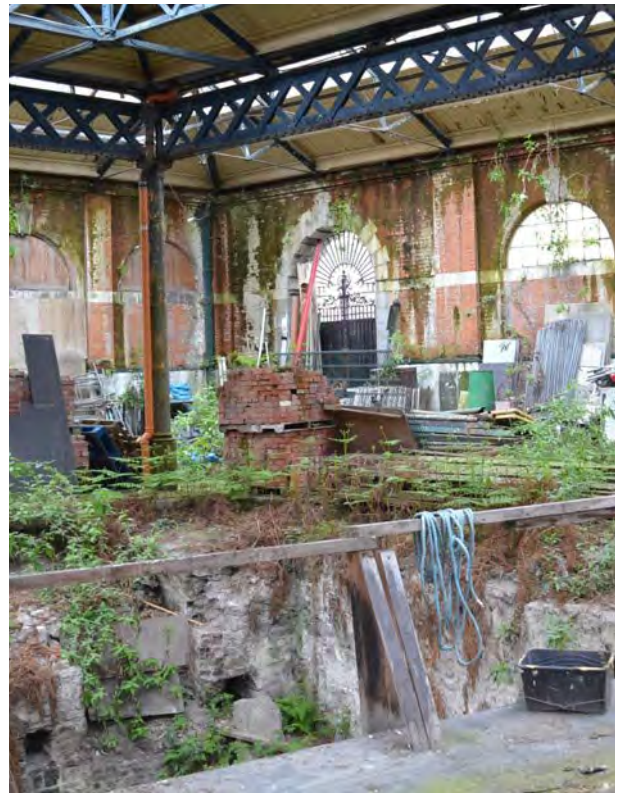
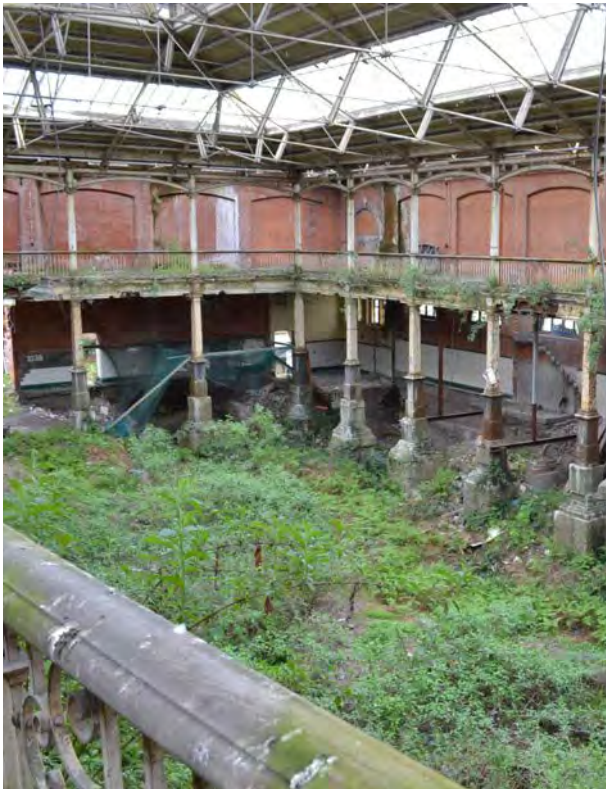
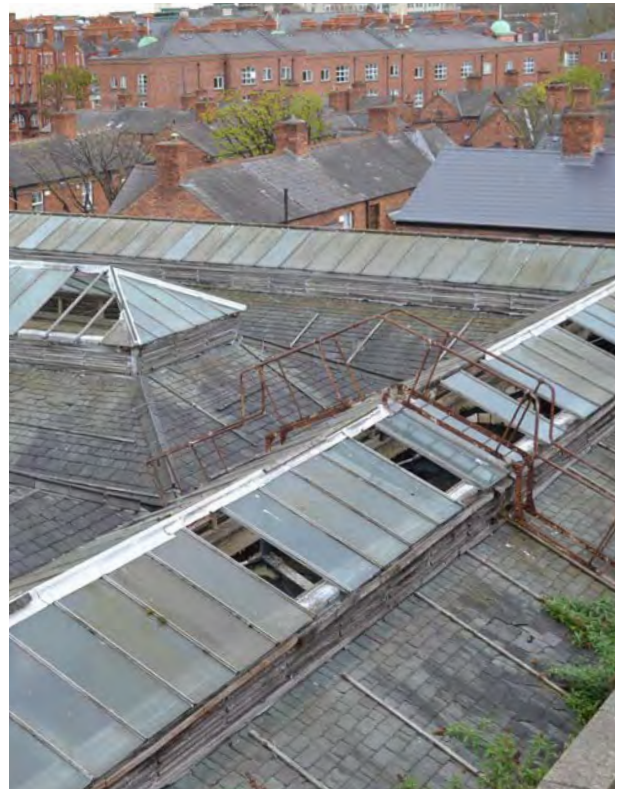
Fig.215 - 218. General images of interior and exterior of markets highlighting areas in urgent need of attention and repair.
