IVEAGH MARKET,  
FRANCIS STREET, DUBLIN 8.

DILAPIDATION SURVEY & REPAIR RECOMMENDATIONS

FV  
January 2019

HOWLEY HAYES ARCHITECTS

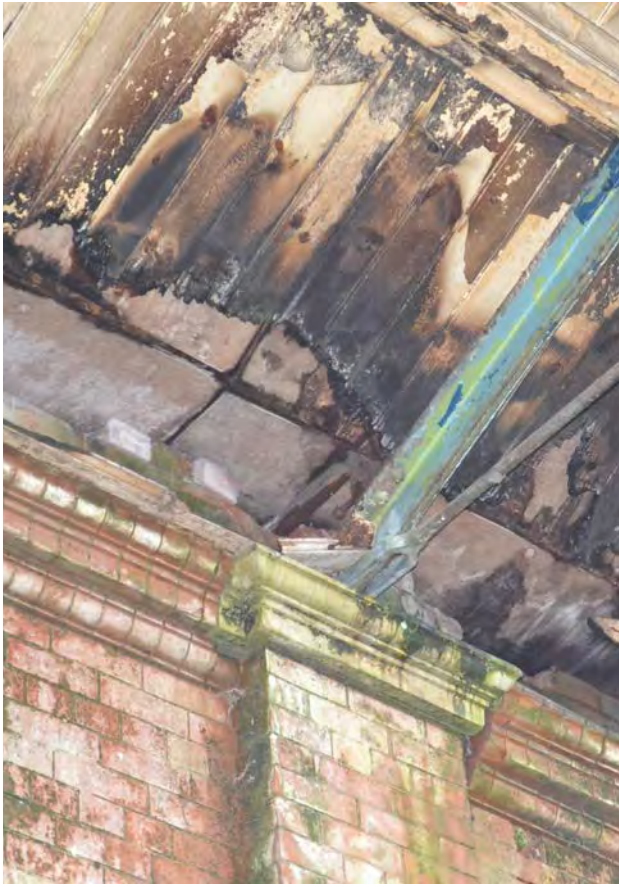
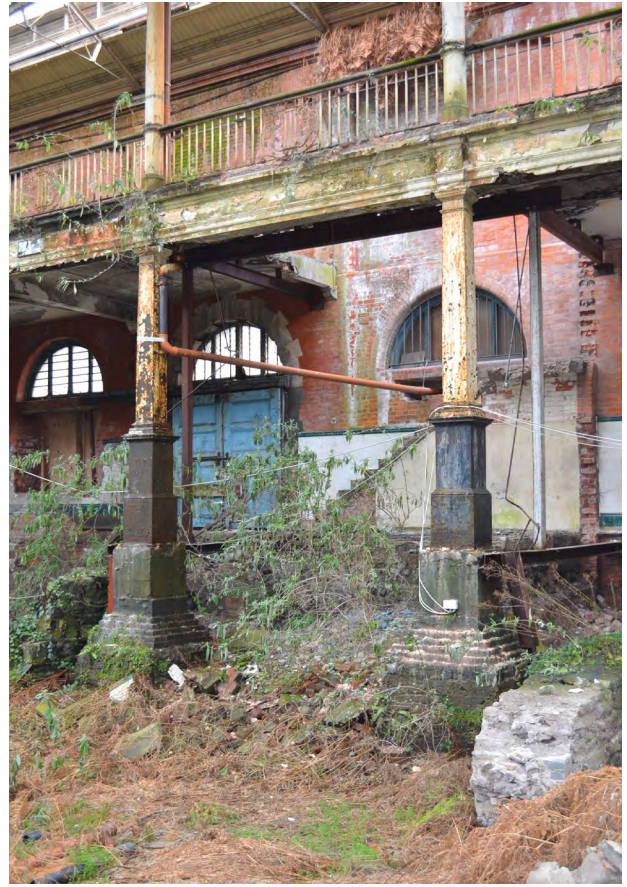
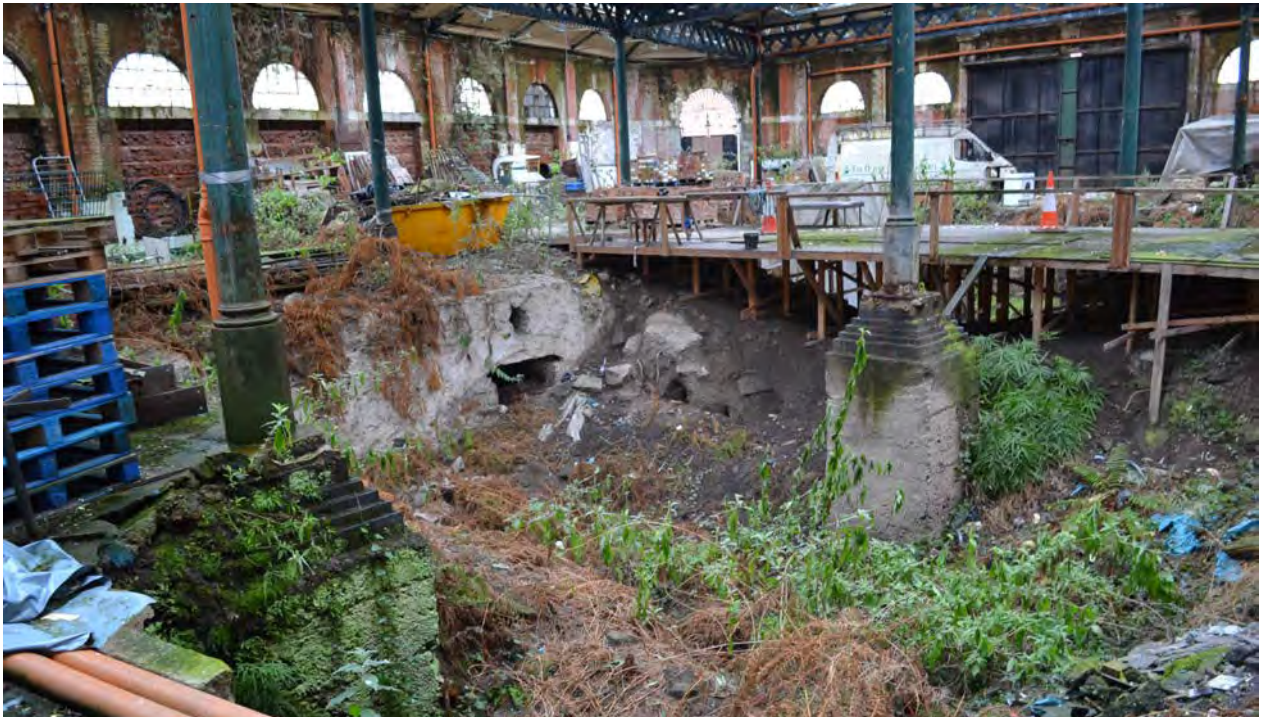
Fig.219 - 221. Excavated ground floor slabs in both halls resulting in precariously exposed foundations of major structural members. Severe rot infestation to underside of roof boarding.

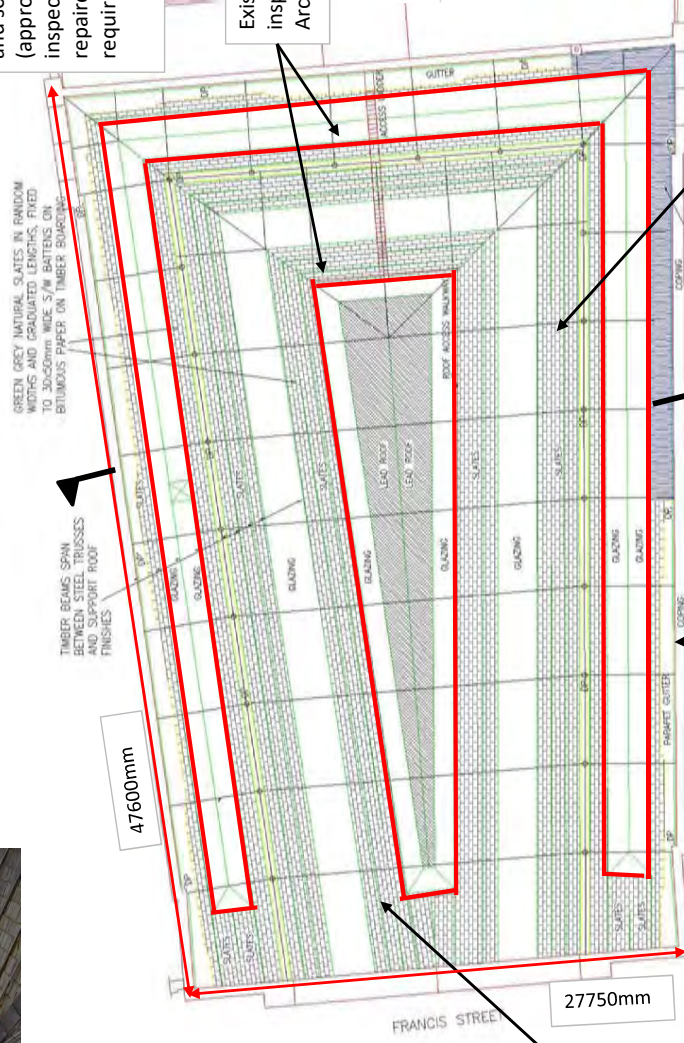
Timber wall plate damaged in places due to water ingress. Timber wall plate to be repaired with new treated timber wall plate (approx. 270mm x 90mm), wall plate isolated from damp brickwork. See green areas on SK12.
