IVEAGH MARKET,  
FRANCIS STREET, DUBLIN 8.

DILAPIDATION SURVEY & REPAIR RECOMMENDATIONS

FV  
January 2019

HOWLEY HAYES ARCHITECTS

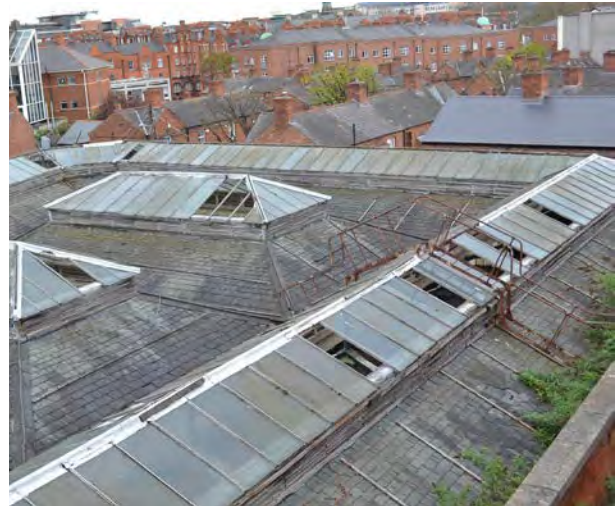
Fig.16. Neglected roof and leaning parapet in NE corner of Wet Market.

Generally the building appears to be at rest, apart from in one location, in the north east corner there are signs of settlement, structural movement and an inward leaning parapet. This damage has been investigated by a structural engineer who has confirmed that a significant section of the parapet will have to be taken down and reconstructed. Other areas of significant damage to the original brickwork have been manmade. One is the insertion of a wide and poorly designed doorway on Dean Swift Square, probably within the last forty to fifty years. While this enlarged opening would have accommodated larger vehicles it is an unsightly intervention that detracts from the historic character of the building and should be reversed. Further, more recent damage has been caused to the interior brickwork by the

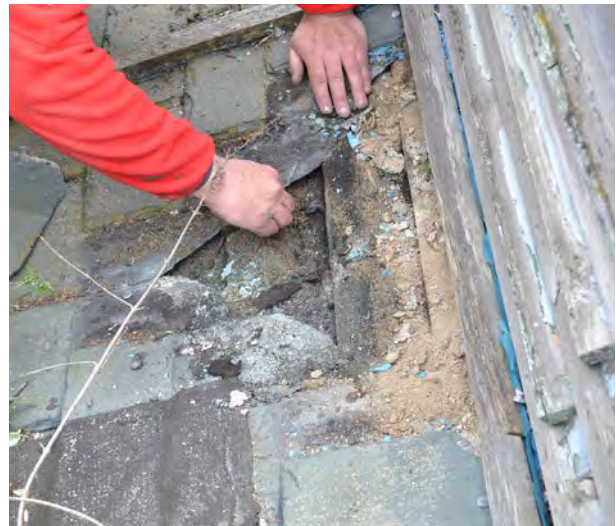
Fig.22. Roof opened up to expose build up.

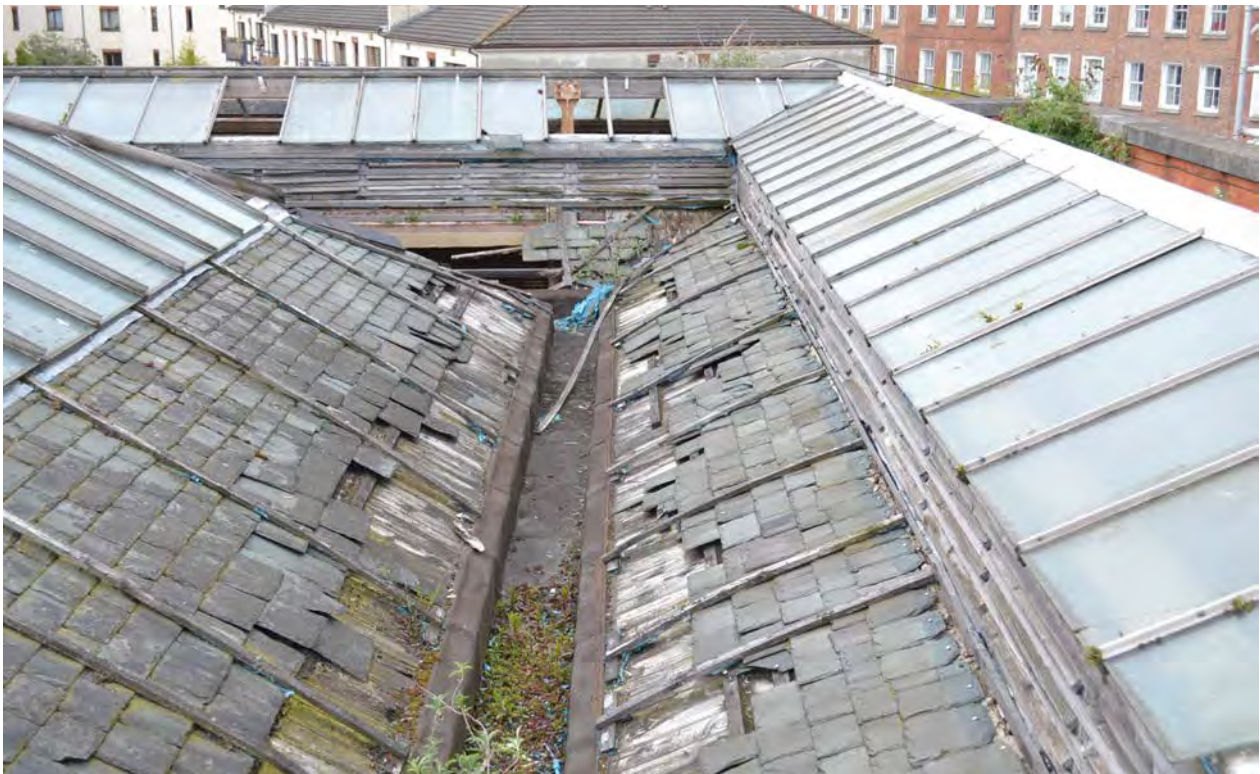
The lack of maintenance is very obvious not just to the roof but to all parts of the building and it would appear that this condition has existed for some considerable time. Plant growth is well established in many parts of the roof, rainwater disposal channels are blocked and there has been no attempt to rectify obvious areas of damage that are permitting serious water ingress. There appear to have been two major interventions carried out to the roof – one was the replacement of the original patent glazing system, probably during the 1980s, and the second the covering of the entire roof with polythene sheeting, probably during the 1990s or early 2000s. At some point the valleys were also lined with poorly applied, short life torch-on felt.

Fig.29. General view of cast iron valley.

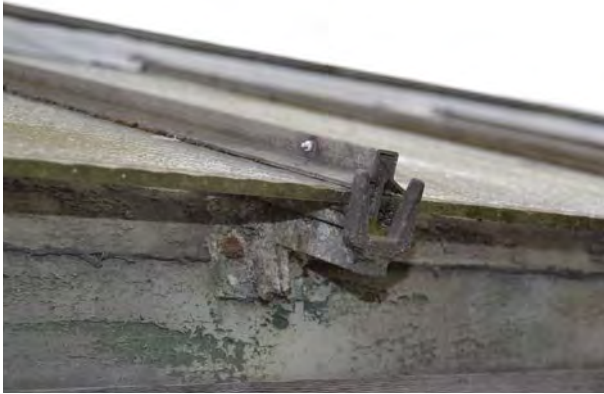
It is not clear why the original patent glazing would have been removed, unless it had for some reason been constructed with timber members, which is unlikely. Patent glazing systems were first introduced around the turn of the twentieth century when the fabrication generally consisted of lead cloaked, steel T-bars with lead flanges to weather the glass. Aluminium systems, such as the one in place on the roof today, were developed during the late 1940s and early 50s. Traditional, lead-cloaked bars are very durable and given the high quality of their materiality and fabrication, it is unclear why they had to be replaced. The current glazing probably dates from the 1980s and given the extent of this installation it is likely that when this was installed some damage was done to adjoining slated roof slopes and the flashings between glass and slate.

Fig.30. Detail of replacement aluminium patent glazing.

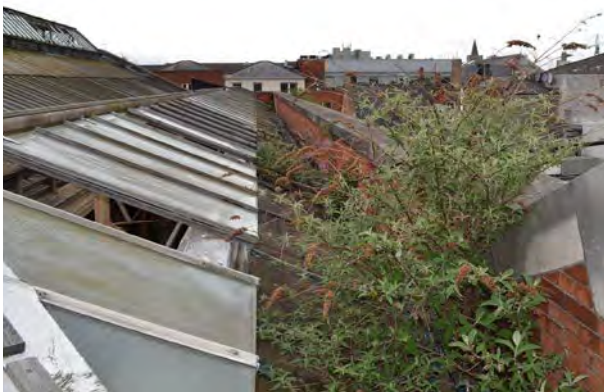
Fig.32. Copious plant growth exists in many of the valleys.

2.E	Remove plant growth from roof and valleys	1	item	10,000.00	10,000
2.F	Inspect/repair/replace timber purlins	1	item	140,000.00	140,000
2.G	Inspect/repair/replace timber wall plate	1	item	20,000.00	20,000

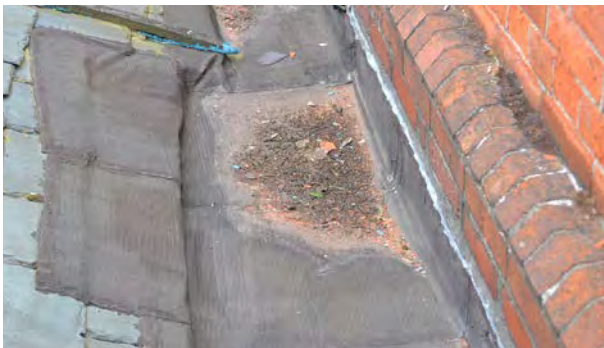
The rainwater disposal system consists of a series of flat valleys, running either behind the parapet of the external walls of each market, or between the outer and inner roofs. From the width and changes in level of the outer parapet valleys, it would appear that these were originally constructed in lead sheet with regular steps as required for this sort of sheet metal lining. Why this was replaced, or possibly only covered is not clear. If properly detailed and fabricated lead valleys should last much longer than 100 years and it is possible that these were stolen for sale in the scrap metal market. The current torch-on felt coatings are poorly installed with inadequate flashings and have failed in many places, causing the timber valley linings to rot and sink.

Fig.40. Poorly relined parapet valleys.

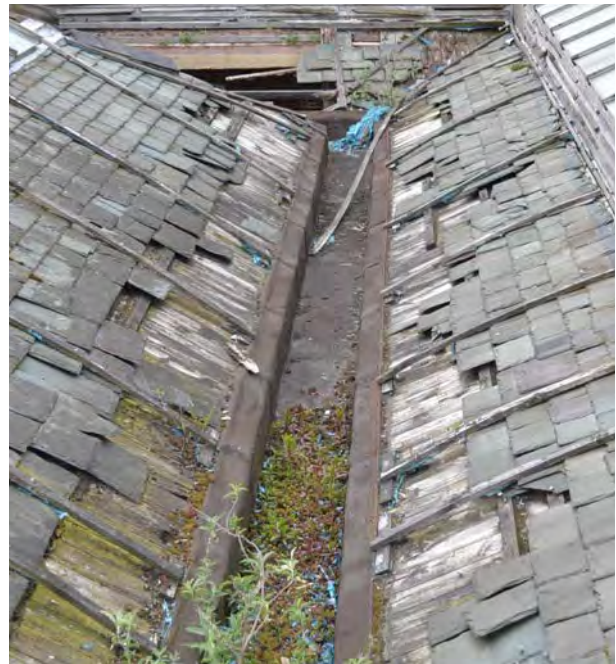
In the construction of the internal valleys it is not possible to step these valleys as easily as can be done to the parapet valleys, so wide, flat valleys have been installed in cast iron. This detail that was used to create flat internal, or sometimes parapet, valleys for large roofs, consists of socket and spigot type joints and can function with minimal falls. These valleys also appear to have been lined with torch-on felt. Felt is often added to these valleys when the joints fail, even though the individual cast iron units survive in a good state of repair and need only to be cleaned and the jointing material renewed. Currently, many of the valleys are blocked, some have considerable plant growth established within them and none appears to be functioning adequately. Originally the valleys discharged into large decorative, cast iron hoppers, some of which survive although most of the original cast iron down pipes have been replaced with UPVC.

Fig.39. General view of cast iron valley.

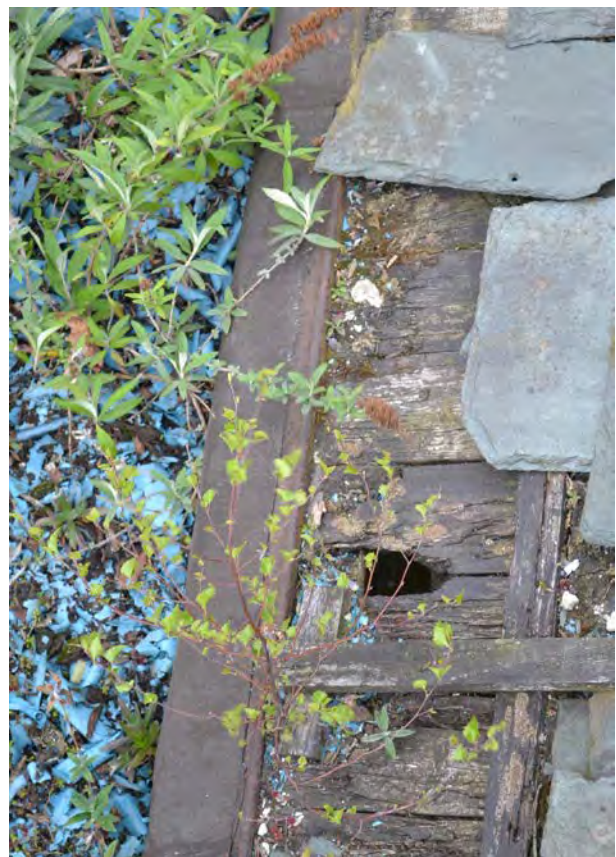
Fig.41. Detail of rotten roof/ceiling boarding and lined cast iron valley.

and purlins. Large areas of these timber linings have now deteriorated due to the widespread outbreaks of wet rot that have resulted from failing roofs and valley gutters. As the timber is of typically high quality there is a possibility that some might be salvaged and reused, however, it is highly likely that most will have to be replaced to matching details.

The entire roof and rainwater disposal system will have to be stripped back to sound material. As the main roof structure is constructed of metal, it is hopeful that this will survive in a reasonable state and will require only localised repair and repainting. All of the beautiful Westmorland slate will have to be stripped, and it is possible that up to 30% might be salvaged for reuse. All battens, boarding and parapet valley linings will have to be stripped and a very large proportion of these will most likely have to be replaced. While the aluminium patent glazing survives in a fair to poor condition, it would be a false economy to try to salvage and reuse these and the glass is similarly of mediocre quality. It may be possible to salvage the cast iron, inner valleys but this will only be known when the roof is stripped. The extent of timber decay in the purlins and the timber framing and louvres of the lantern plinths is likely to be significant and a high proportion of replacement will be necessary in this area as will the other decorative timber trims and cover pieces seen from inside. Repairs will also be necessary to the access ladders and gantries and when repaired these will play an important part in providing safe access for regular, on-going maintenance to the repaired roof.

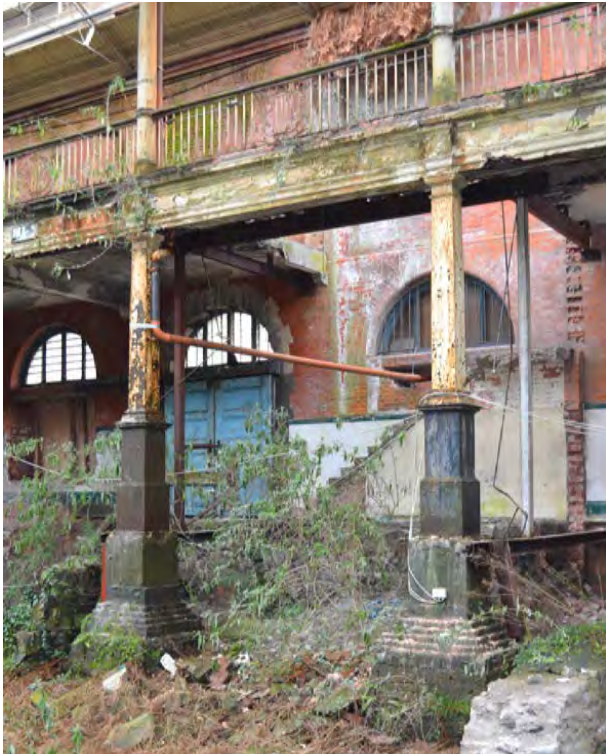
Fig.46. Detail of balcony in Dry Market with excavated column bases.

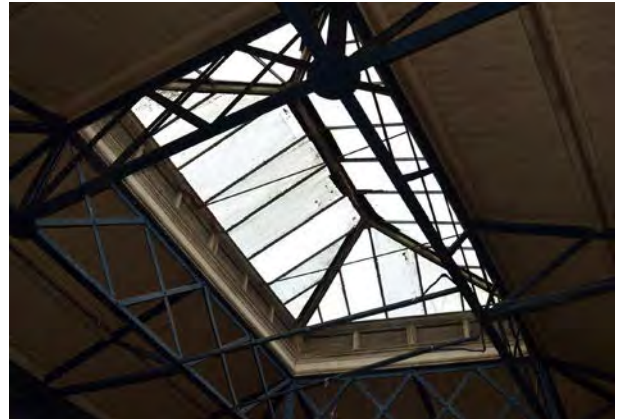
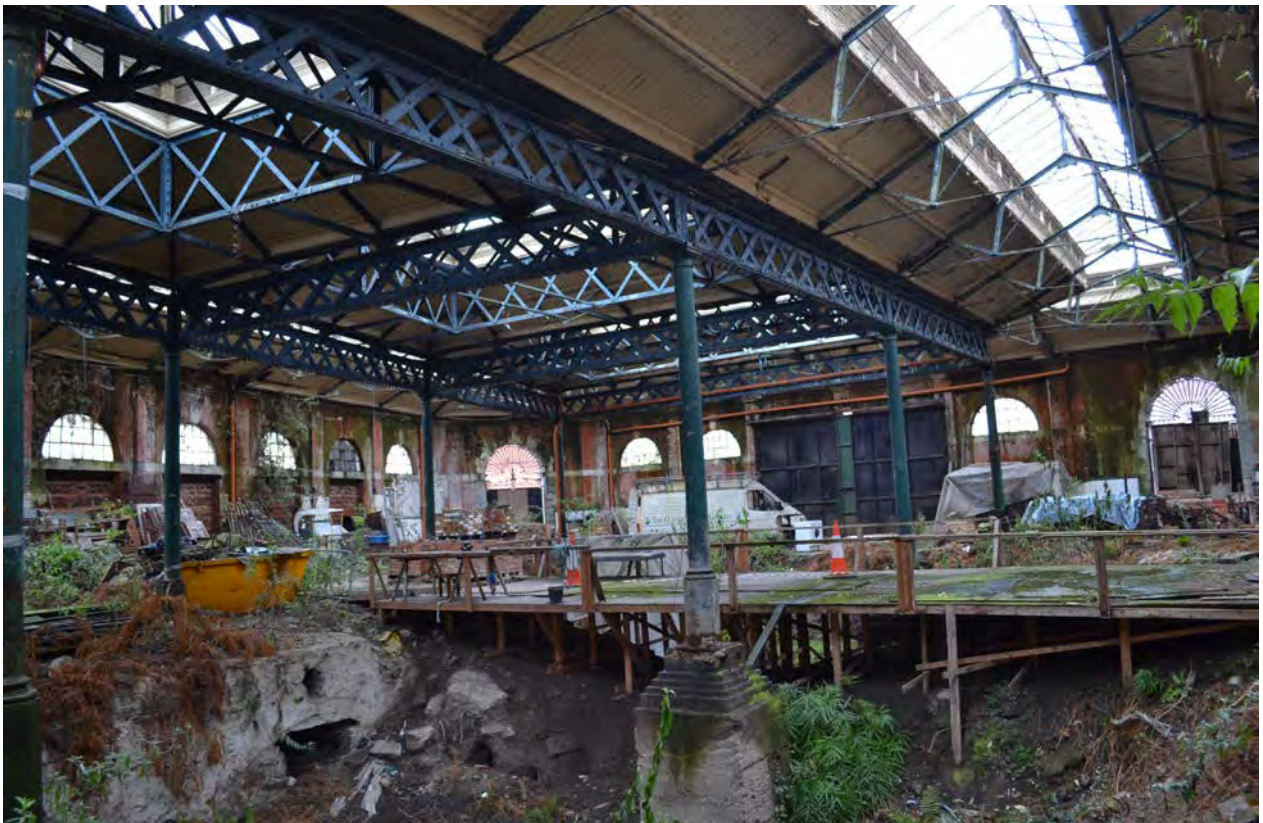
Unlike the timber elements in the roof structures, the metal frame survives in a reasonable state of preservation albeit a poor state of repair. Serious outbreaks of rust are apparent in some locations and a high number of local repairs can be anticipated, particularly around rainwater outlets, but for the most part the structure appears to be structurally sound and suitable for repair and reuse.

Fig.50, 51. Details of roof in the Wet Market.

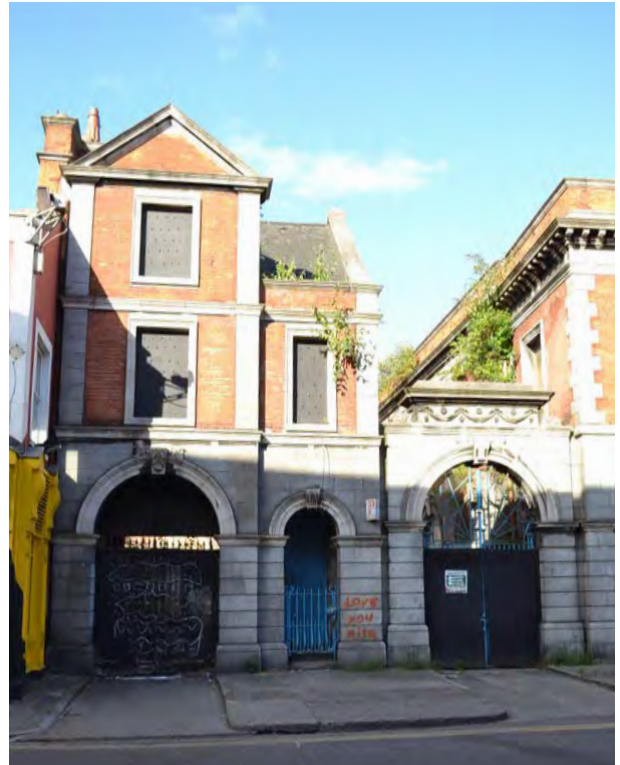
Fig.59. Significant plant growth on the Dry Market and market superintendent's house.

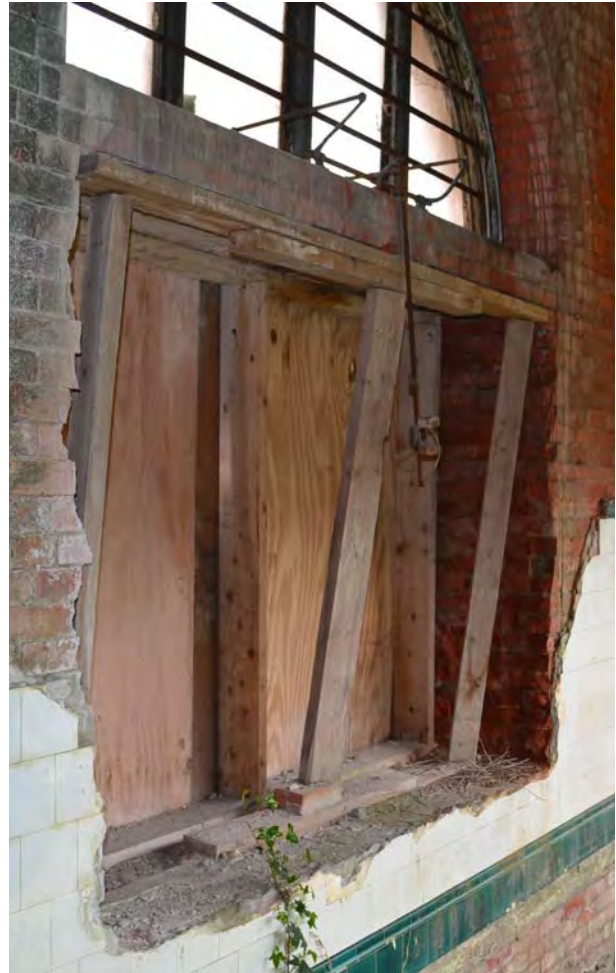
removal of the brick panels under the Diocletian style windows beneath the north gallery of the Dry Market. Currently the arched windows plus two courses of brickwork directly underneath their cills are supported precariously on timber props or by hanging metal frames, and these require urgent attention to avoid further damage. Brickwork has also been removed from the inner wall faces underneath some of the east facing windows in the former Wet Market, while brick partitions have been removed from the central, single-storey range between the two market halls and around the two staircases in the Dry Market. In the wet market only the inner portion of the wall thickness has been removed so the windows above them retain some measure of support. However, this damage should also be repaired as a matter of urgency.

Fig.70. Brickwork walls removed under arched windows in north façade.

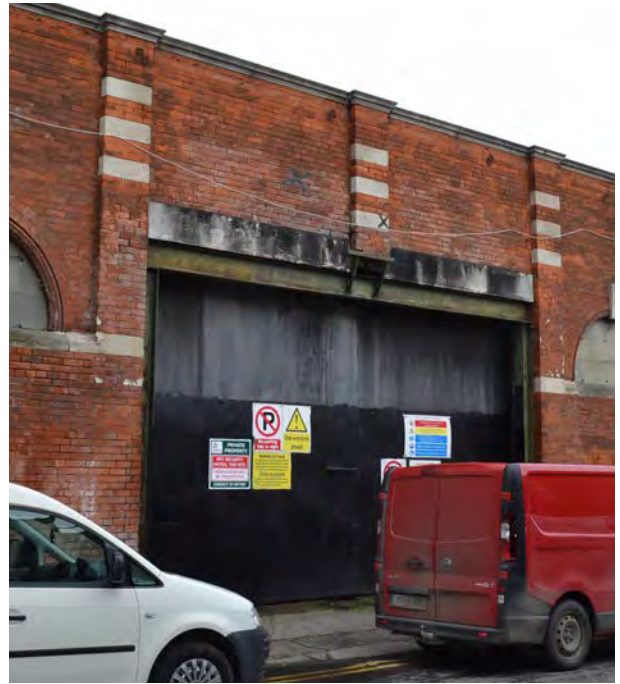
Fig.72. South façade of Wet Market with crudely inserted doorway.

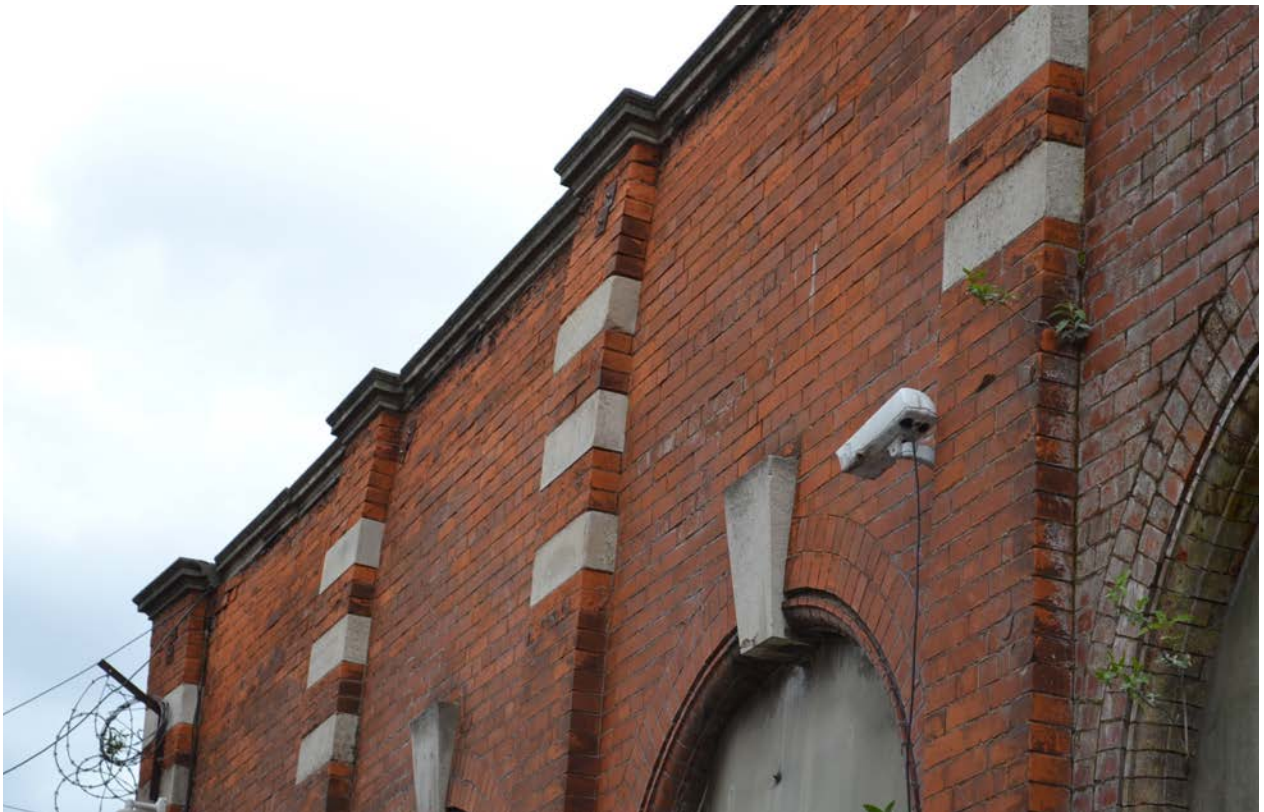
Fig.73. Leaning parapet in North East corner from passage.

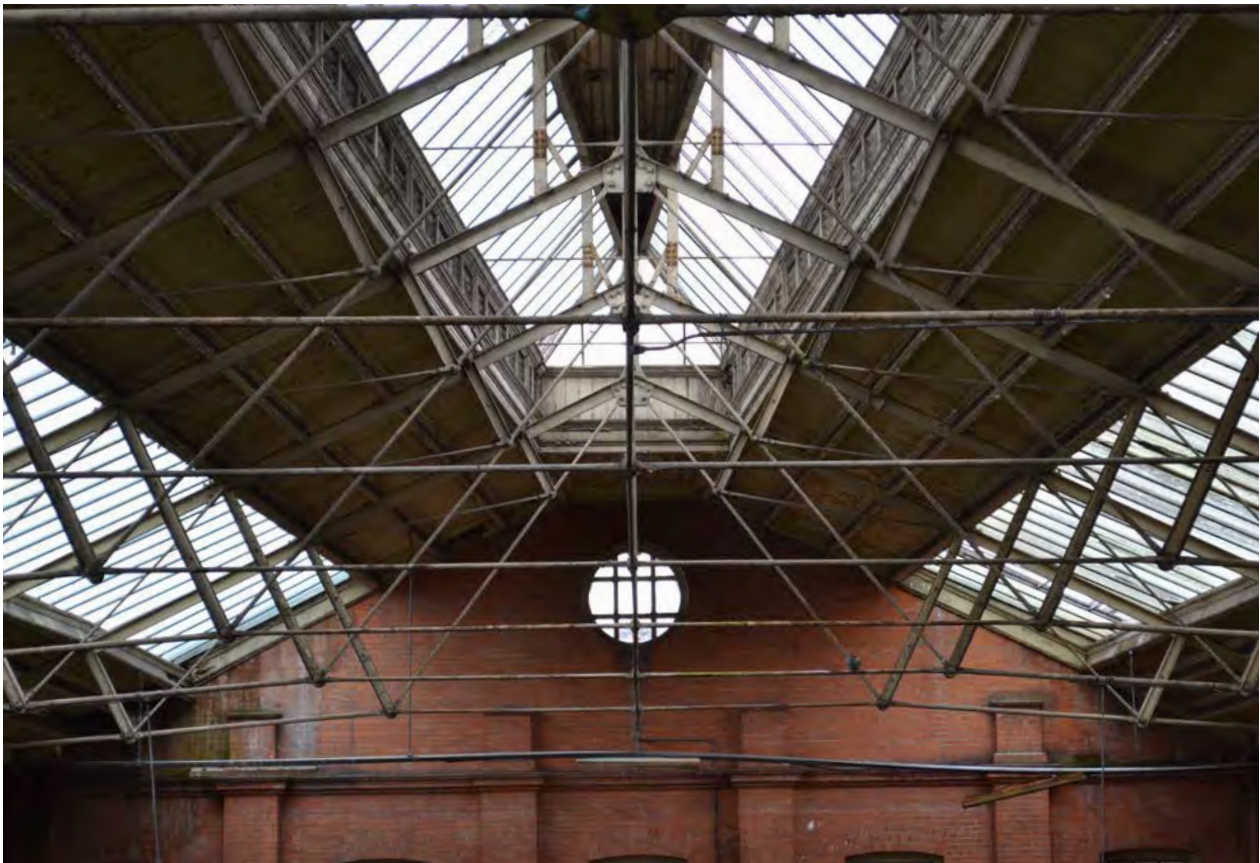
Fig.87. Detail of Dry Market roof structure.

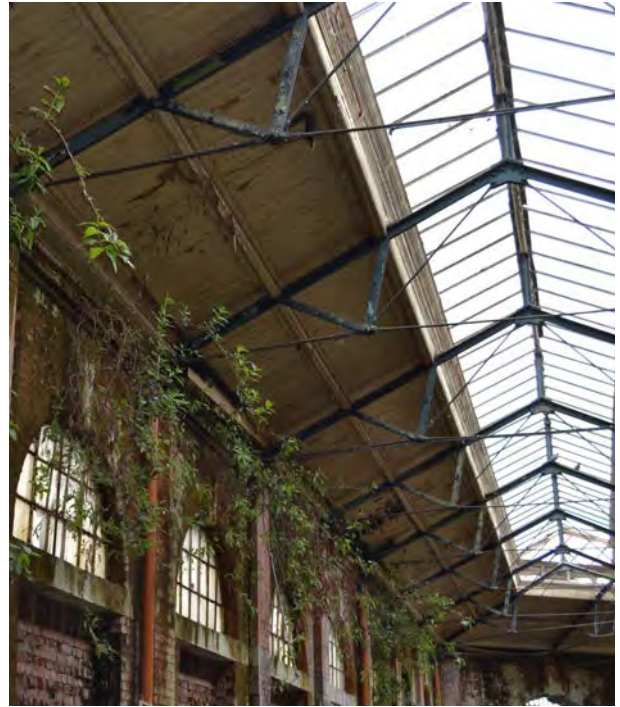
Fig.89. Roof and east wall of Wet Market.

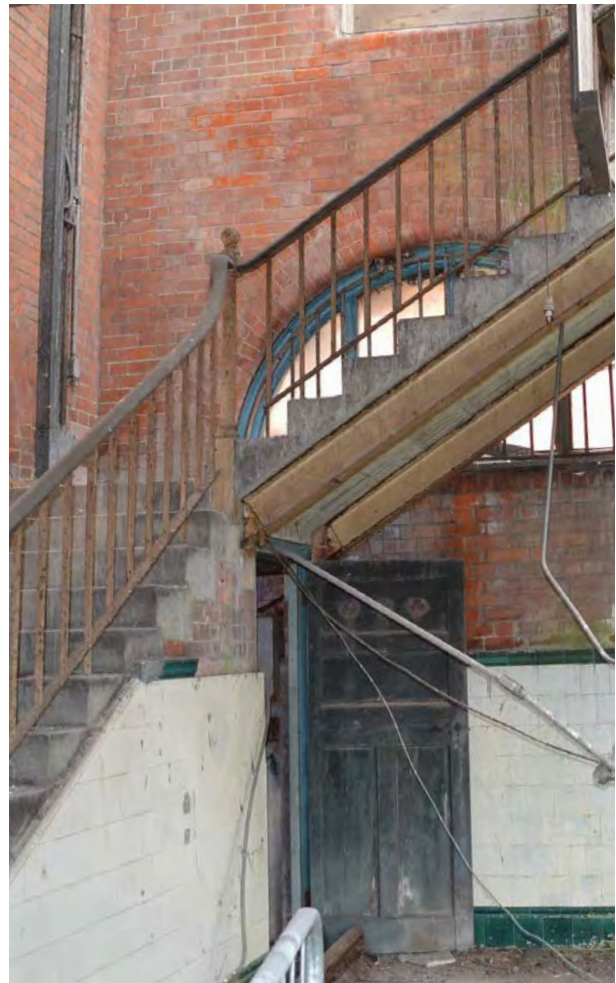
Fig. I07. View of the one surviving staircase.

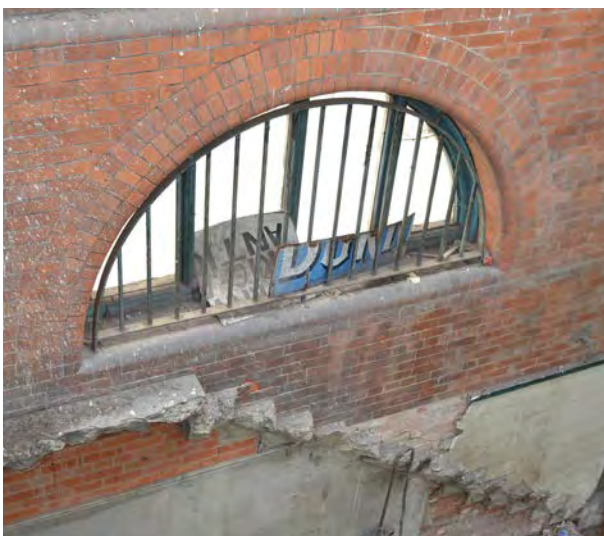
Fig. I06. Scar left on wall where concrete staircase was removed.

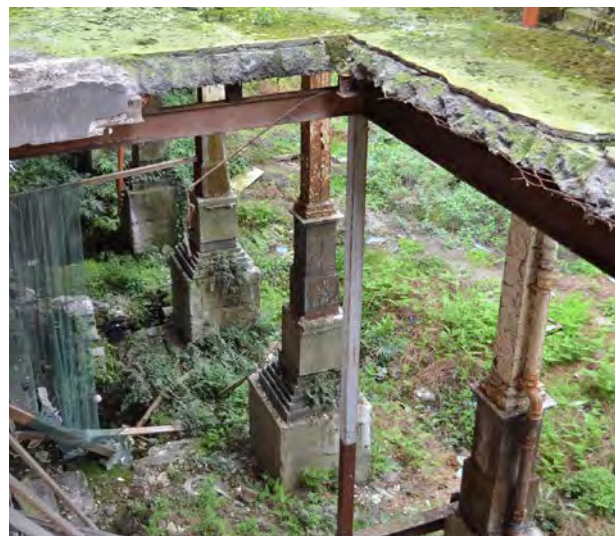
Fig. I08. Void in gallery slab where south staircase removed.

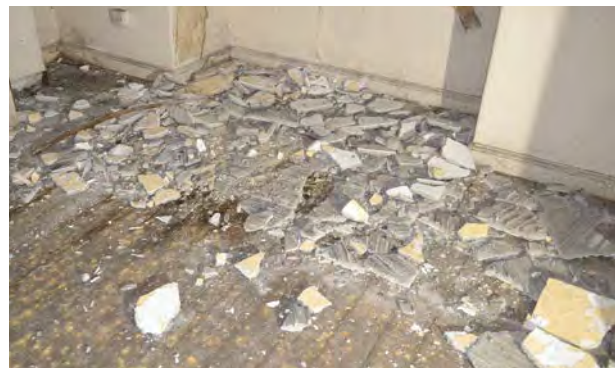
Fig. I 13. Ceiling collapse and wood boring insect infestation to second floor in the market superintendent's house.

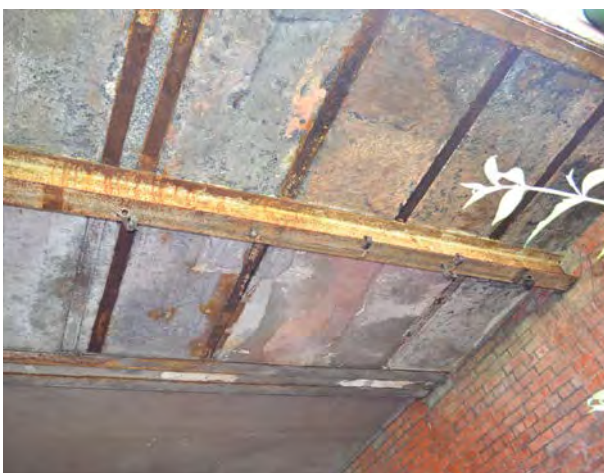
Internally there is a combination of concrete pot and beam floors, some with additional steel beam supports. Almost all of these floors require some degree of concrete repair. While the upper sides of the concrete floor are covered with narrow timber boarding, the undersides of these concrete floors are simply skimmed and painted and also require repair as many are cracked. Some of the boarding show signs of significant insect attack. In the two-story southern bay the floors are timber framed with boarded floors and plastered ceilings. These are mostly in poor condition but are salvageable with repair.

Fig. I 14. Underside of steel and concrete first floor to market superintendent's house from carriageway.

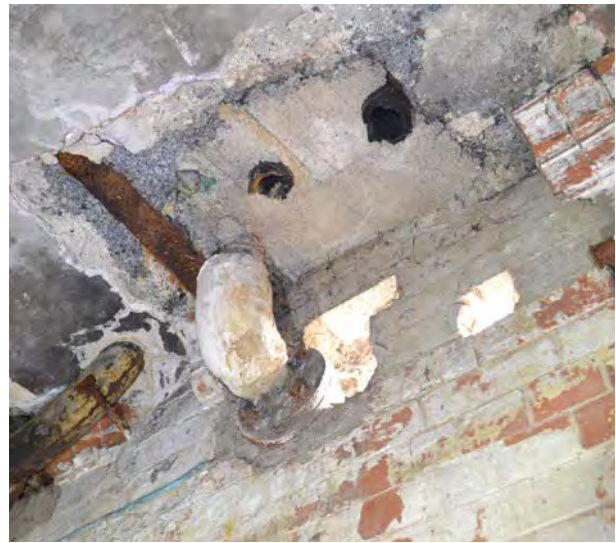
Fig.208. Open well in concrete ground floor where basement staircase removed in laundry superintendent's house.

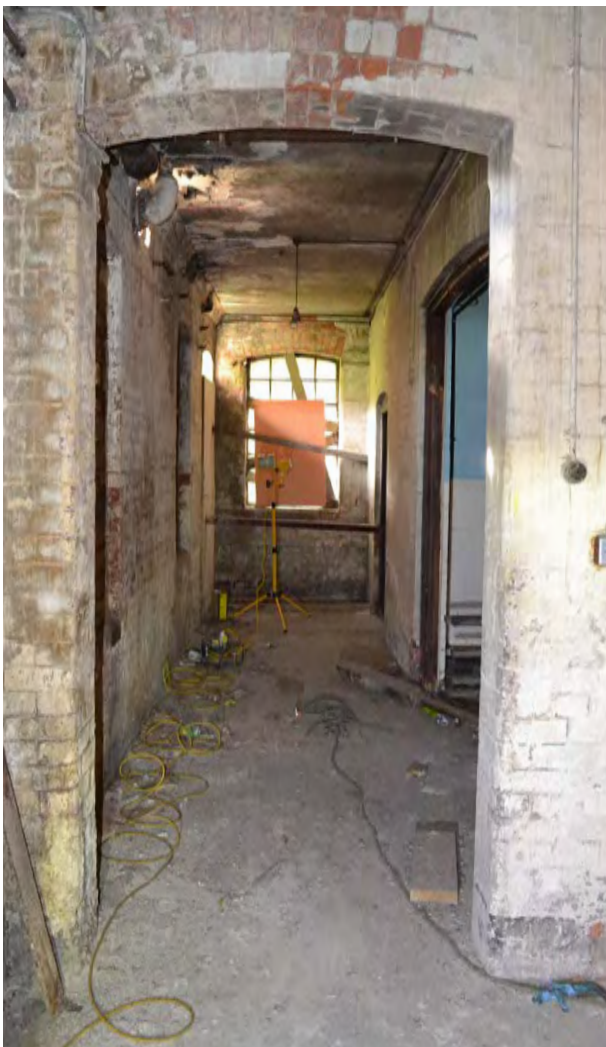
There are signs of dampness throughout the basement area, where most of the painted surfaces are peeling and damaged. Brick walls and partitions are stained and floor slabs damaged and crumbling in many places. Extensive damp treatments will be required in these areas that are currently largely unventilated.

Fig.209. Corridor in former laundry.

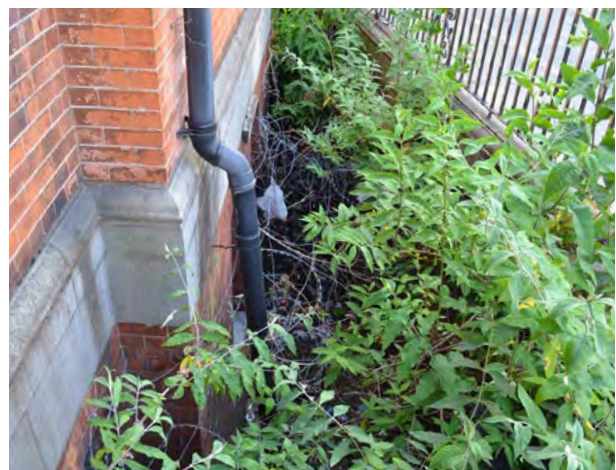
Fig.212. Overgrown area in front of the laundry superintendent's house.

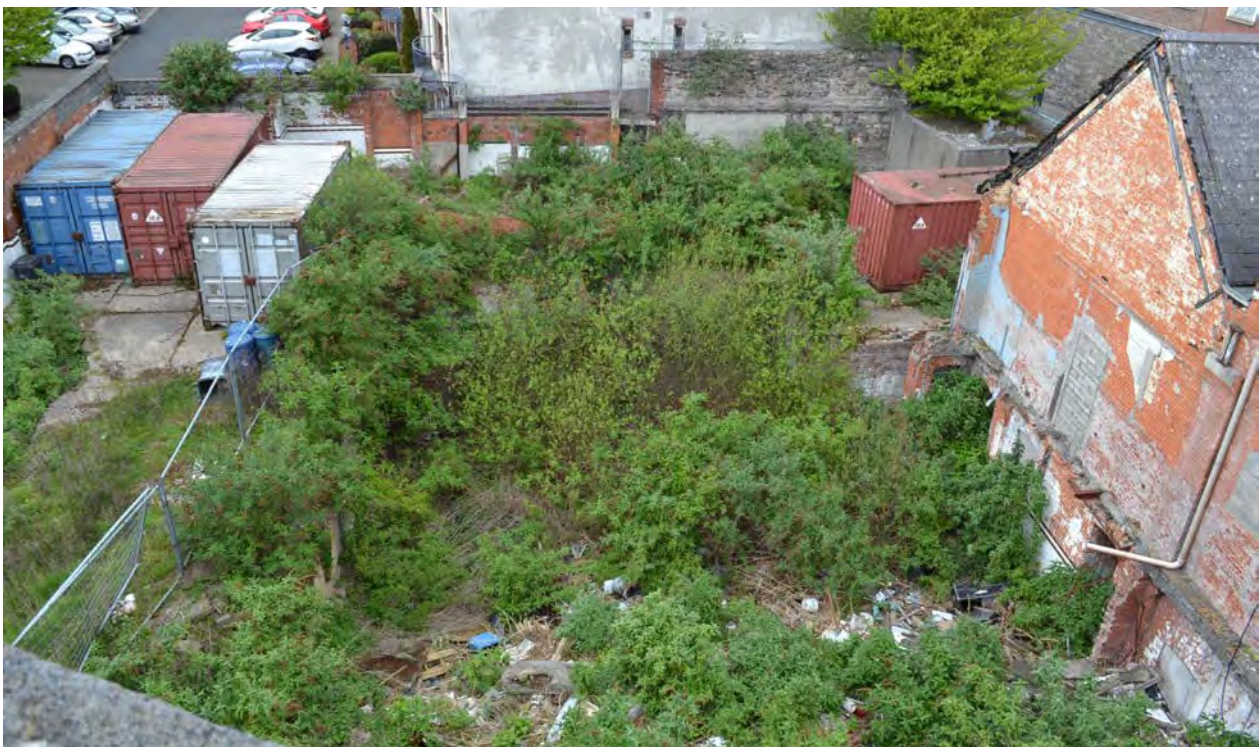
Today the entire area has been almost totally excavated and like the interiors of the two market halls, no temporary propping has been put in place to support adjoining party and party boundary walls. Dense plant growth has colonised this space all of which will have to be removed to properly assess condition. It is likely that some structural stabilisation will be necessary to the party boundary walls on the north side and also to the superintendent's dwellings and what remains of the laundry on the east and west sides. Subject to the archaeological finds in this area the back-filling and stabilisation might include the construction of a basement level.

Fig.214. Site of former laundry buildings – now demolished and excavated.

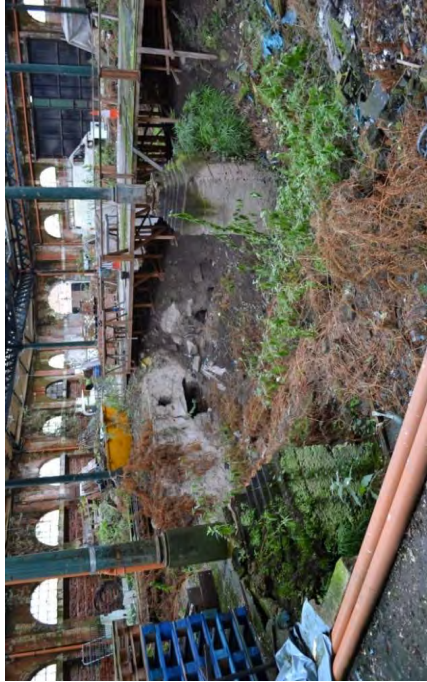
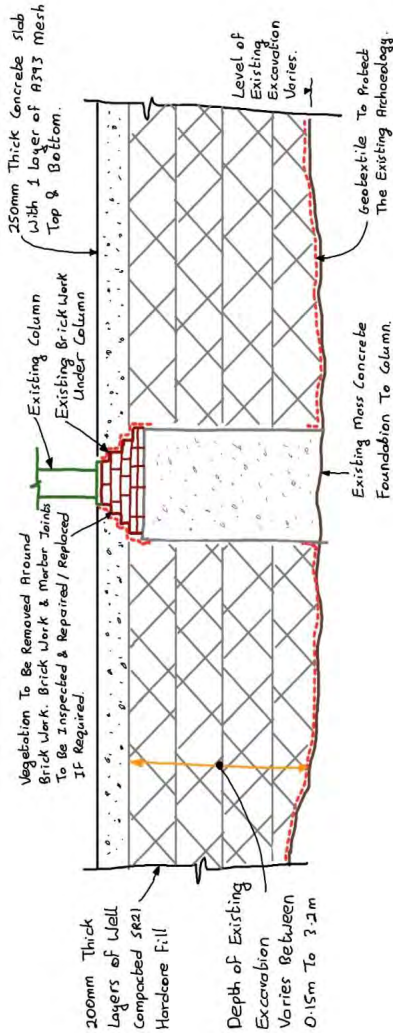
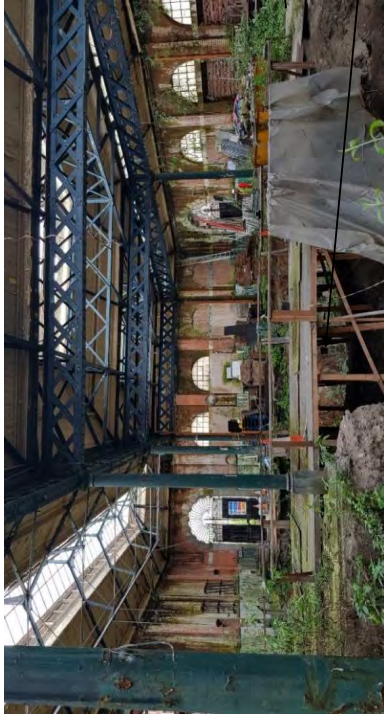
Depth of existing excavation varies. Vegetation and all other deleterious material to be removed before excavation is back filled.

250mm Concrete slab with 1 layer of A393 mesh top and bottom with 50mm cover, laid to falls to drainage channels and gullies, on 200mm thick layers of SR21 hardcore fill on Geotextile to protect the existing Archaeology.

Existing foul sewer to be inspected and repaired. New surface water line to be installed. See sketch SK05 for drainage details. Existing concrete slab to be cut out to allow for drainage to be installed. Concrete slab to be reinstated with a new 250mm thick concrete slab with 1 layer of A393 mesh top and bottom, with H12 bars doweled into existing slab at 200mm centres.

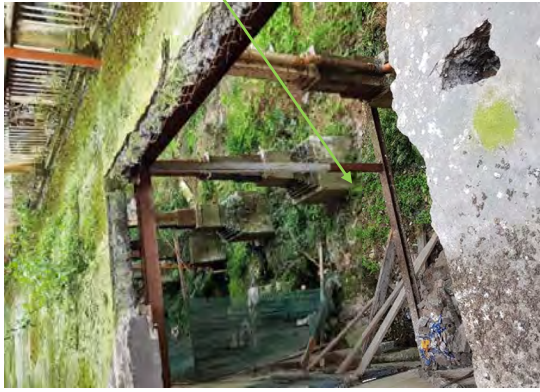
Vegetation to be removed from mezzanine floor and walls. Any loose bricks or mortar to be removed and repaired. Note areas highlighted in green likely to be more severely deteriorated.

Brickwork to be repaired where temporary drainage passes through existing wall with new brickwork. Dry packing rammed tightly between new brickwork and existing brickwork.

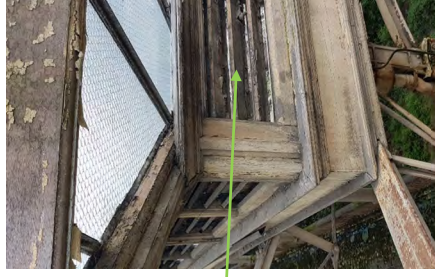
Timber wall plate damaged in places due to water ingress. Timber wall plate to be repaired with new treated timber wall plate (approx. 270mm x 90mm), wall plate isolated from damp brickwork. See green areas on SK12.

Existing steel trusses, beams and columns to be inspected for deterioration and repaired were required. All steel to be sand blasted on site and painted on site with a corrosion protection paint.
